# **SR 26 / University Avenue Multimodal Emphasis Corridor Study**

## **DRAFT Phase 2 Report**

**May 2015**

**Metropolitan Transportation Planning Organization  
for the Gainesville Urbanized Area**

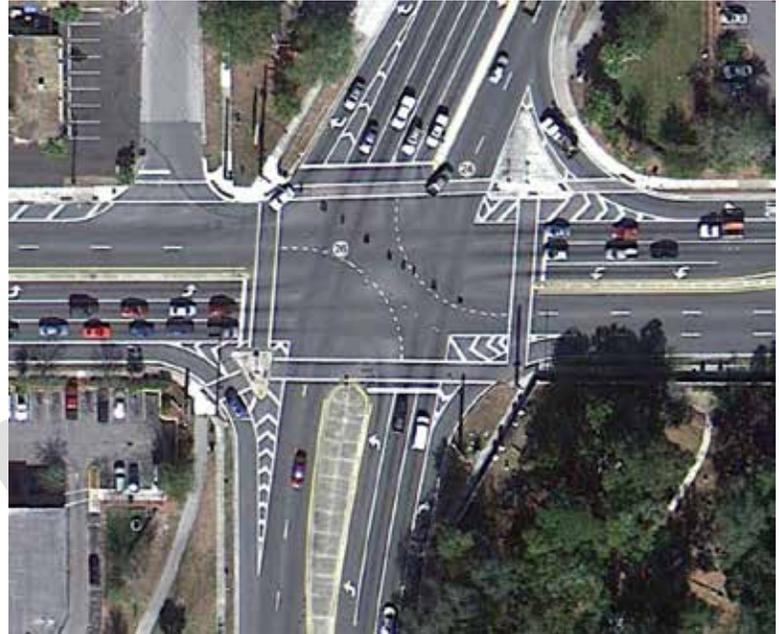
Figure 1 SR 26 at Waldo Road Existing Configuration

The existing configuration of the intersection of SR 26 and Waldo Road is shown in Figure 1. There were two specific comments regarding this intersection made during the Technical Advisory Committee (TAC) walking tour (preliminary Phase 1 field assessment). The first was that the southeast corner of the intersection includes a free-flow (uncontrolled) right turn lane across two *signalized* crosswalks. The second comment was that the pedestrian crossings are quite long.

The uncontrolled right turn across the two signalized crosswalks results in pedestrians receiving a WALK signal when the vehicles are under free-flow operations. Essentially, this tells pedestrians they are permitted to start to cross the roadway in the direction of the signal indication. While crossings with a WALK signal can occur with conflicting turning vehicles, those vehicles approaching from a perpendicular or near perpendicular direction normally have a red signal. Thus pedestrians may reasonably expect the vehicle operators turning right from the direction that has the red traffic signal (or at least the through movements have a red traffic signal) to be required to stop and yield prior to making a right turn on red. However, under the existing condition on the southeast corner of this intersection, there is nothing to inform the free-flow north-to-east right turning motorists that the pedestrian's traffic control has changed. This could lead to confusion and safety issues at this intersection.

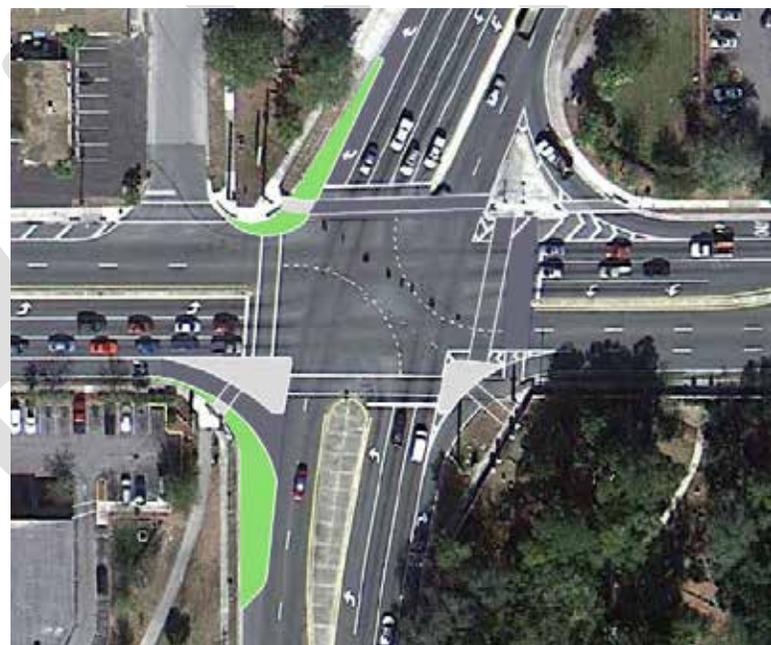
Figure 3 SR 26 and Waldo Road, Compact Design

More significant modifications using pedestrian friendly intersection design could further reduce pedestrian crossing distances. The northwest corner could be modified to reduce the crossing distance for pedestrians as well as reduce motor vehicle turning speeds. Gap acceptance slip lanes on the northeast and southwest would also reduce motor vehicle speeds across the pedestrian crosswalks. Additionally, modified slip lanes would put the pedestrians crossing in a better position to be seen by approaching motorists. Depending on the size of the channelization islands installed, they could be used to provide a gateway treatment onto the University Avenue corridor. AASHTO's A Policy on the Geometric Design of Streets and Highways<sup>2</sup> allows for trucks to use the receiving width of the roadway. Finally, the *TURNING VEHICLES YIELD TO PEDESTRIAN* sign (R10-15) should be considered on the northbound to eastbound and eastbound to southbound approaches. The conceptual intersection design is shown in Figure 3.

- reconstruction of the radius returns on the northwest and southwest corners of the intersection,
- assessment and modification of drainage structures on the northwest and southwest corners of the intersection
  - one inlet on the northwest corner and
  - two inlets on the southwest corner,
- installation of the channelization island on the southeast corner of the intersection,
- relocation of the pedestrian signal buttons and indications from the southeast corner of the intersection to the concrete island,
- reconstruction of the channelization island on the southwest corner of the intersection,
- traffic signal adjustments on the channelization island on the southwest corner of the intersection,
- additional signing at the southeast and southwest corners of the intersection, and
- removal and replacement of the crosswalk markings on the eastern leg of the intersection.

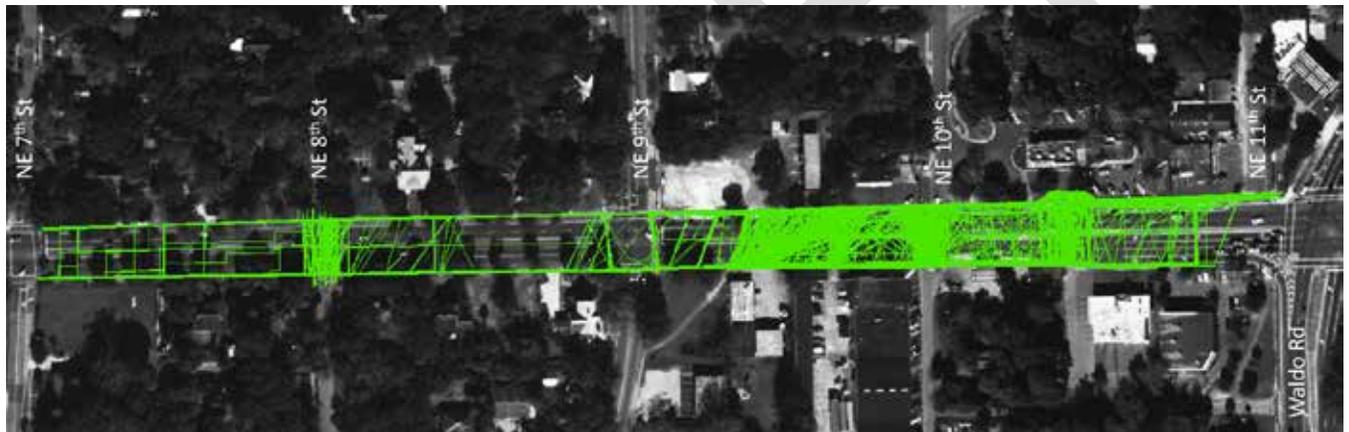
Figure 4 Pedestrian Paths Mapped between E 7th St and Waldo Rd

SR 26 from E 7<sup>th</sup> Street to the beginning of the raised median east of 10<sup>th</sup> Street was video recorded to map pedestrian movements. Data was collected for the Thursday, Friday, and Saturday, February 5-7, 2015. Visibility during the 0:00-2:00 hours on February 5th were sub-optimal due to rain. One thousand three hundred and forty (1,340) pedestrian movements in which pedestrians crossed SR 26 were mapped (Figure 4). These pedestrian crossings fell into several categories.

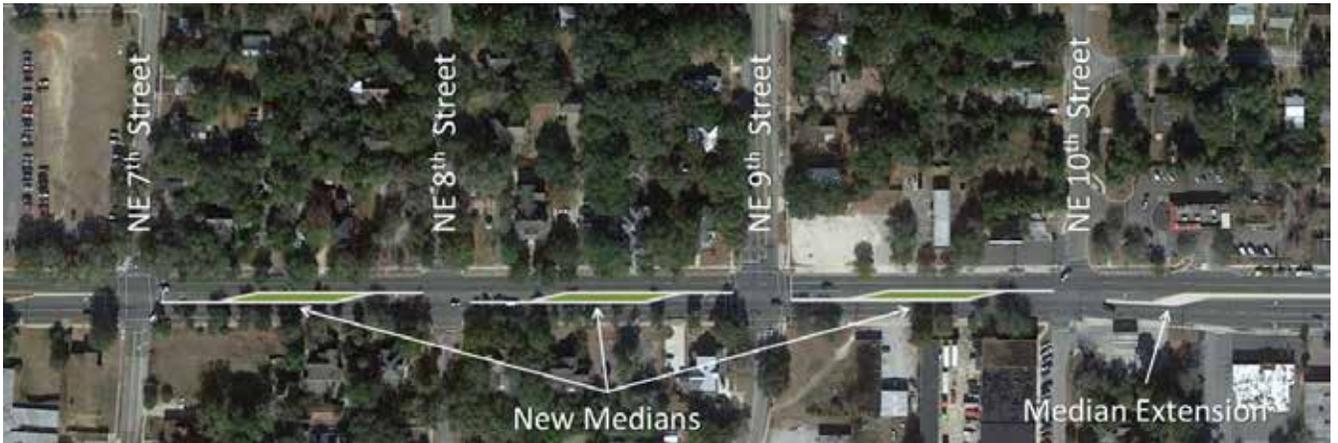
Figure 8 Recommended Medians between 7th Street and 10th Street

Given the above, a raised median is recommended to be installed between E 7<sup>th</sup> Street and the existing median east of E 10<sup>th</sup> Street. Between E 7<sup>th</sup> Street and E 9<sup>th</sup> Street, the FDOT Straight Line Diagram indicates this section of roadway has four 12-foot lanes and a 13-foot painted turn lane. Narrowing the travel lanes to 11 feet would allow for the provision of a 17-foot median where there are currently two-way left turn lanes and a 6-foot traffic separator where there are dedicated left turn lanes (which would be 11 feet wide). The 2015 revision of the FDOT *Plans Preparation Manual* (Table 2.1.1) specifies lane widths of 11 feet for divided urban arterials with design speeds of 45 mph or less. East of E 10<sup>th</sup> Street the median could widen to encompass the current painted median (Figure 8). The existing and proposed cross sections are shown in Figure 9.

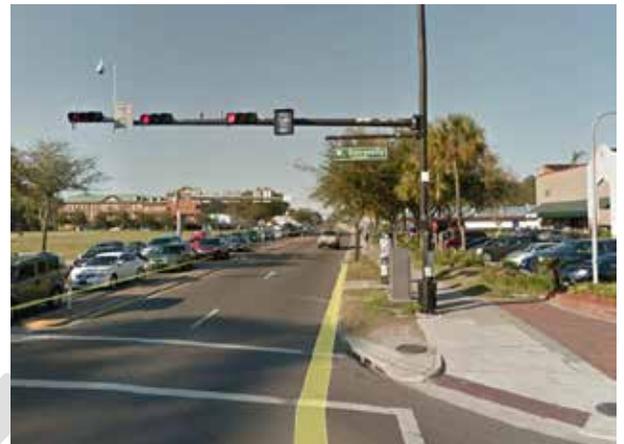
Figure 12 No RIGHT ON RED Blank Out Sign at SR 26 and 13th Street

Allowing activation of the blank out signs when the corresponding pedestrian buttons are pushed would allow for this restriction while not prohibiting right turn on red when pedestrians are not present. Discussions with City of Gainesville traffic engineering staff suggests that while it is not trivial to reprogram the controllers for this type of on-demand blank-out sign operating, it is possible at these intersections. The implementation of this improvement would require City staff to reprogram the controllers. If implemented, pre- and post-implementation compliance rates should be evaluated.

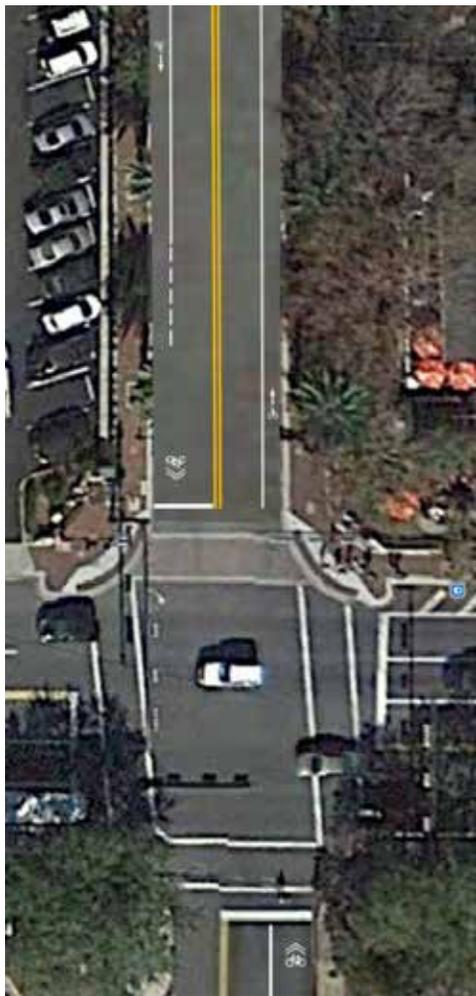
Figure 14 Potential Markings for NW 17th Street and SW 17th Street

The recommendation for this location is for the bike lane to be terminated in advance of the intersection and SHARED LANE MARKINGS installed on the final approach. Alternatively, the BICYCLE DETECTOR could be used instead of a SHARED LANE MARKING. Both the north and south approaches could have either marking placed at the intersection to both inform the bicyclists of where to place their bicycles to be detected by the signals and to encourage them to move their bicycles further into the through lanes. This marking pattern is shown in Figure 14. The SHARED LANE MARKING may be more familiar to Gainesville residents and thus be a better symbol to use.

- modification of the southbound bike lane striping, and
- installation of BICYCLE DETECTION (or SHARED LANE MARKINGS) on the north and south approaches to the intersection.

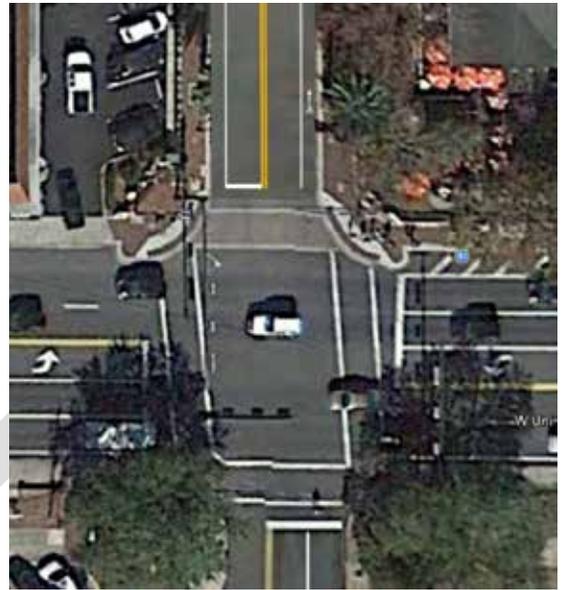
Figure 13 NW 17th Street and University Existing Markings

The northern approach to this intersection has the bike lane striped all the way to the stop line. This solid-stripe-to-the-intersection striping is inconsistent with the MUTCD, the AASHTO *Bike Guide*,<sup>5</sup> and the Florida *Greenbook*.<sup>6</sup> Also, a solid line separating the bike lane from the general lane at an intersection discourages motorists from approaching the intersection and turning right from “as close as practicable to the right-hand curb or edge of roadway.”<sup>7</sup> This movement to the right is required by Florida’s uniform traffic laws. It also encourages bicyclists making a through movement to stay on the right side of the pavement all the way up to the intersection. The combination of these behaviors encourages “right hook” type conflicts. The (approximate) existing striping is shown in Figure 13.

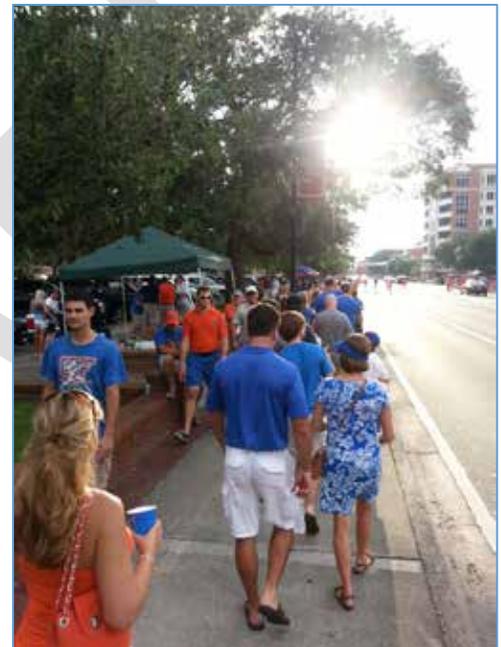
Figure 16 Pedestrian Traffic along SR 26 on a Game Day

The south side of SR 26 between Gale Lemerand Drive and W 13<sup>th</sup> Street generally forms the northern boundary of the University of Florida and is an area of particularly high east-west bicycle and pedestrian activity, primarily consisting of student travel. This section of SR 26 provides non-motorized access to Ben Hill Griffin Stadium, the O’Connell Center, Library West, and multiple residence halls and classroom buildings, and also provides crossing access to key destinations on the north side of SR 26. The existing configuration of this section includes an 8-foot sidewalk located directly at the back of curb. The majority of the section also includes a second sidewalk-like facility, separated from the other sidewalk by a low brick wall and a planting strip that is located on University property. Given the lack of comfortable bicycle accommodation within University Avenue itself, each of these facilities experiences a heavy mix of bicycle and pedestrian travel, creating the potential for conflicts between the modes. This is especially true during peak travel, including on football and basketball game days, and frequently leads to the functional capacity of the sidewalk being exceeded (Figure 16).

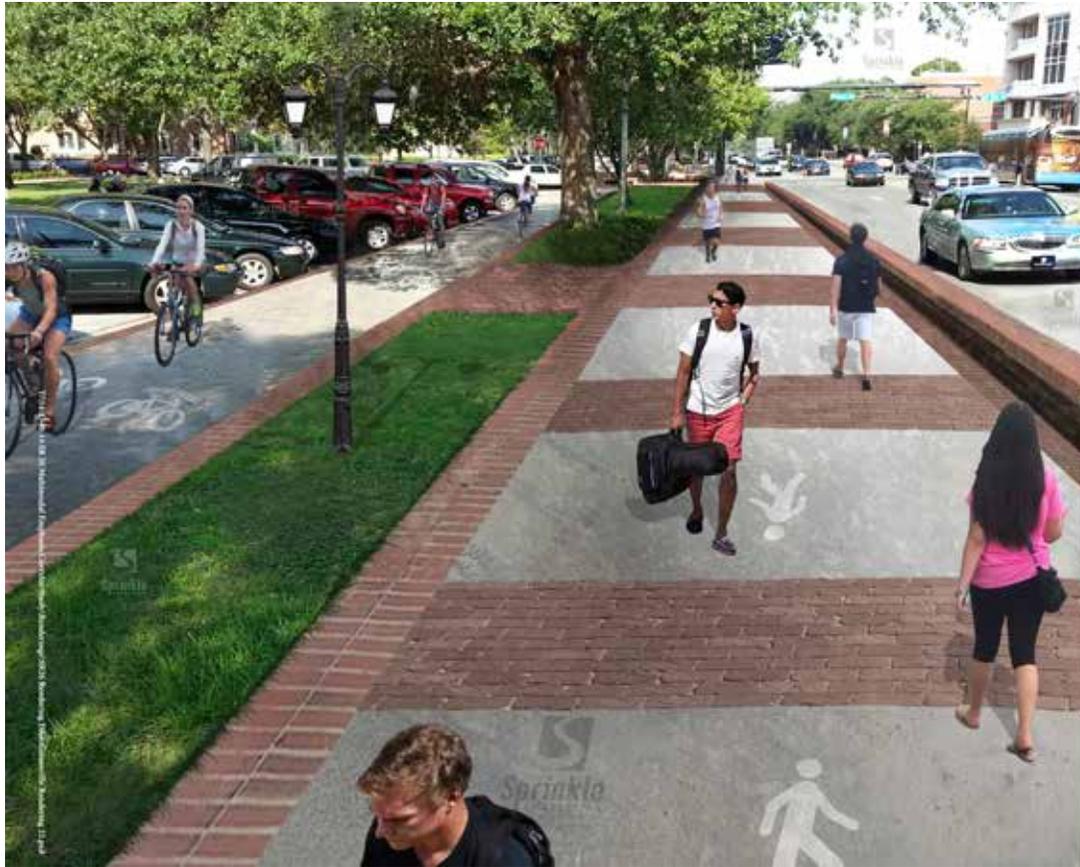
University Avenue  
Pedestrian  
and Bikeway  
State Road 26  
Gainesville, FL  
Option "C"  
Rendered by  
Sprinkle Consulting  
April 3, 2015

There are several potential options for a project that would enable the reconfiguring of the south side of SR 26 to significantly better accommodate both pedestrian and bicycle travel through this section. As part of this second study phase, three concepts/options have been developed and discussed with University staff to determine feasibility and willingness of the University to become a project partner. All of the options under consideration include improved lighting in the area, create chicanes at existing intersections for the campus-side facility to enhance bicycle safety, and require minor modifications to existing parking lots. Two options leave both facilities open to bicycle and pedestrian travel but delineate (through signage and pavement markings) travel paths for each mode. Another option uses the campus-side facility for exclusive bicycle travel and the SR 26 sidewalk for exclusively pedestrian travel, and incorporates a 32-inch wall with a 2 ½-foot clear recovery zone setback from SR 26 designed to assist in channelizing users to certain SR 26 crossing locations. A conceptual rendering of this third option is shown in Figure 17. This design, or a hybrid approach among the proposed options, would help solve the modal conflict and facility capacity problems described above while encouraging active transportation and multi-modalism within this section of the study corridor.

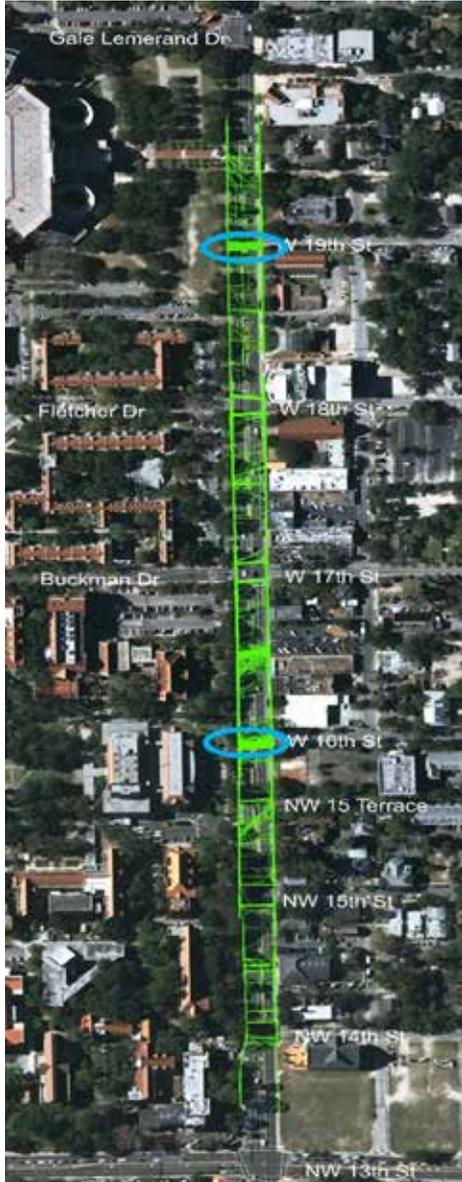
Figure 18 Pedestrian Crossing Map of SR 26 from 14th Street W to Gale Lemerand Dr

In addition to enhancing bicycle and pedestrian accommodation along SR 26, there is a desire to better accommodate pedestrian crossings of SR 26. During the TAC walking tour (preliminary Phase 1 field assessment), numerous participants reported they routinely witness pedestrian midblock crossings of this section of SR 26. The TAC members expressed the desirability of channelizing pedestrians to designated crossings, and the creation of additional controlled crossings - focusing pedestrian crossings to predictable locations.

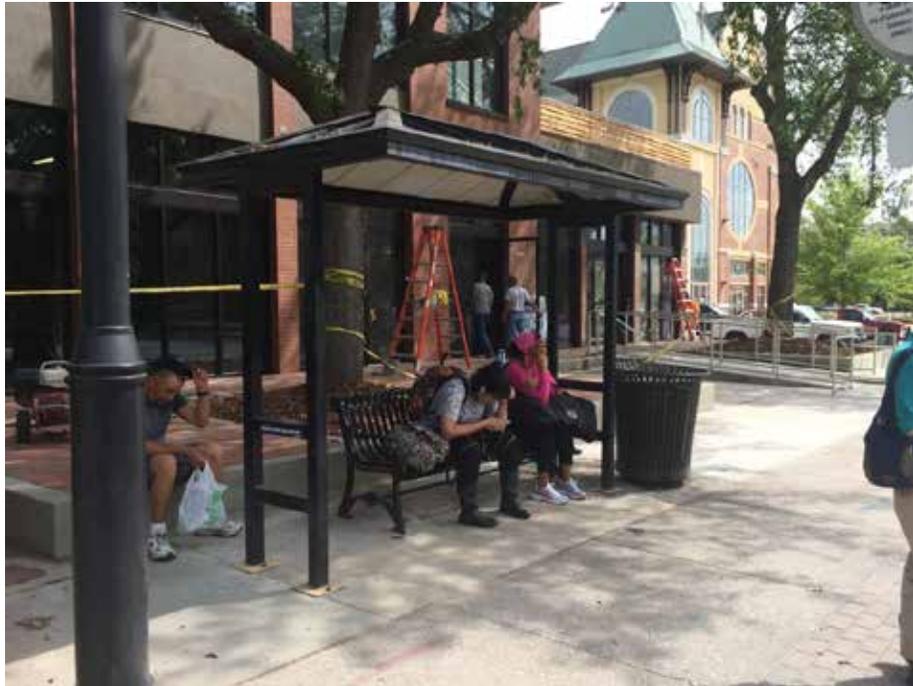
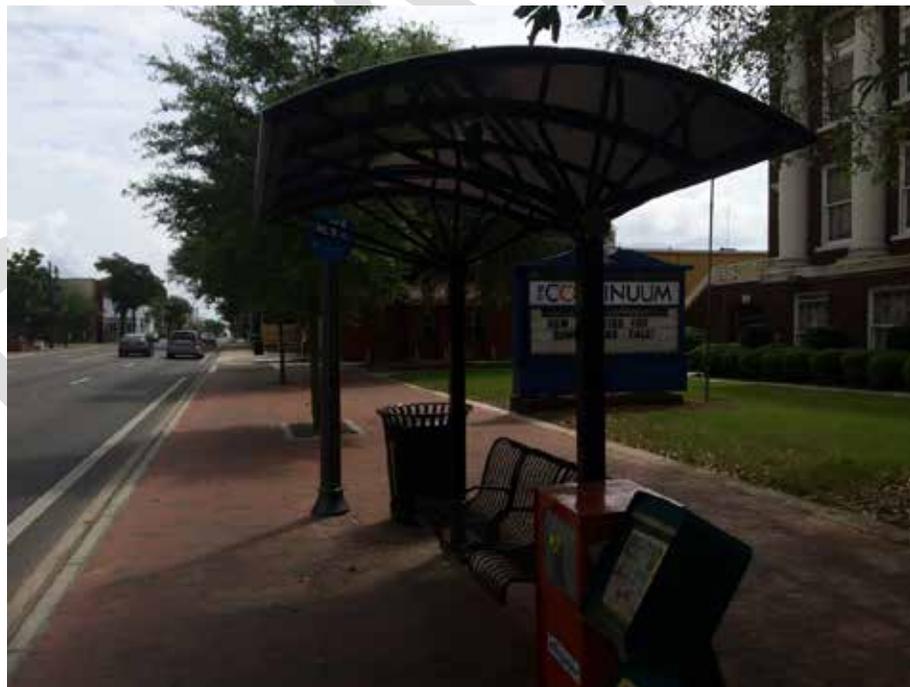
Figures 19 and 20 show typical configurations of a small RTS bus stop shelter.

Figure 19 Photo of existing shelter at RTS stop located on westbound SR 26 at NW 14th Street

Figure 20 Photo of existing shelter at RTS stop located on eastbound SR 26 at SW 6th Street

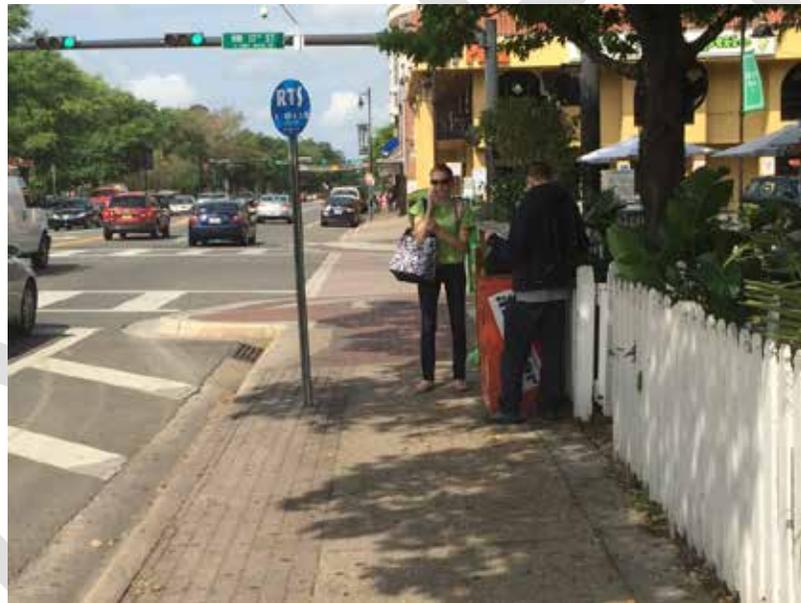
Figure 22 Photo looking west from RTS stop located on westbound SR 26 at NW 17th Street

This stop is located about 80 feet away from the nearest overhead light source. There is no opportunity, with the existing stop layout, to locate the stop closer to the overhead light due to the proximity to the crosswalk and intersection. Therefore, the level of lighting is not adequate and the installation of a lighted shelter is recommended.

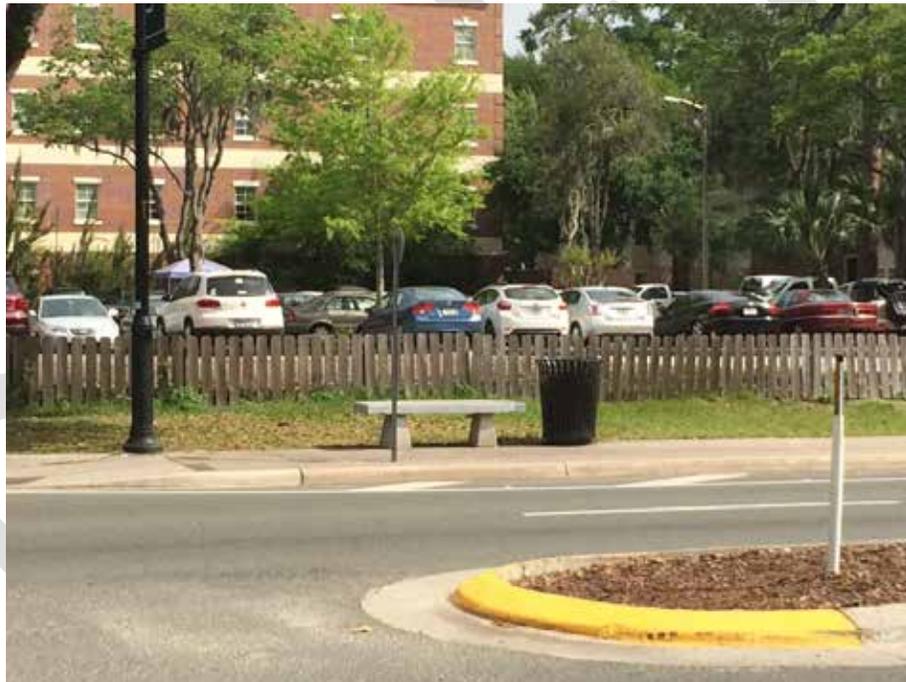
Figure 23 Photo looking north from across SR 26 to RTS stop located on westbound SR 26 at NW 16th Street

This stop is located about 10 feet away from the nearest overhead light source. However, the roof of the shelter could block the light and the installation of a lighted shelter is recommended.

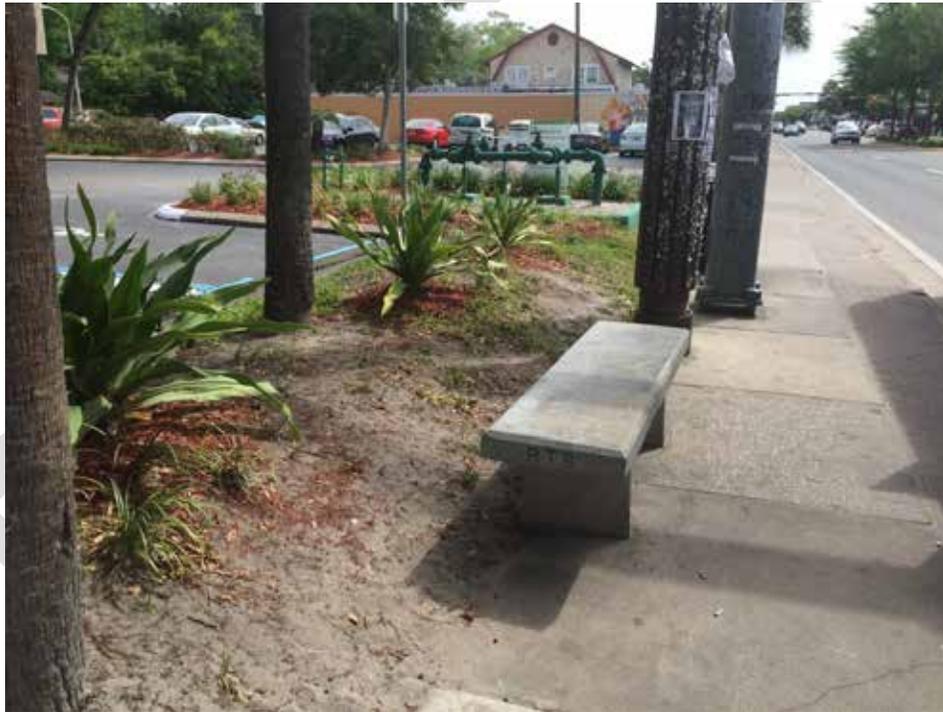
Figure 24 Photo looking east from RTS stop located on westbound SR 26 at NW 13th Street

This stop is located about 30 feet away from the nearest overhead light source. However, the roof of the shelter could block the light and the installation of a lighted shelter is recommended.

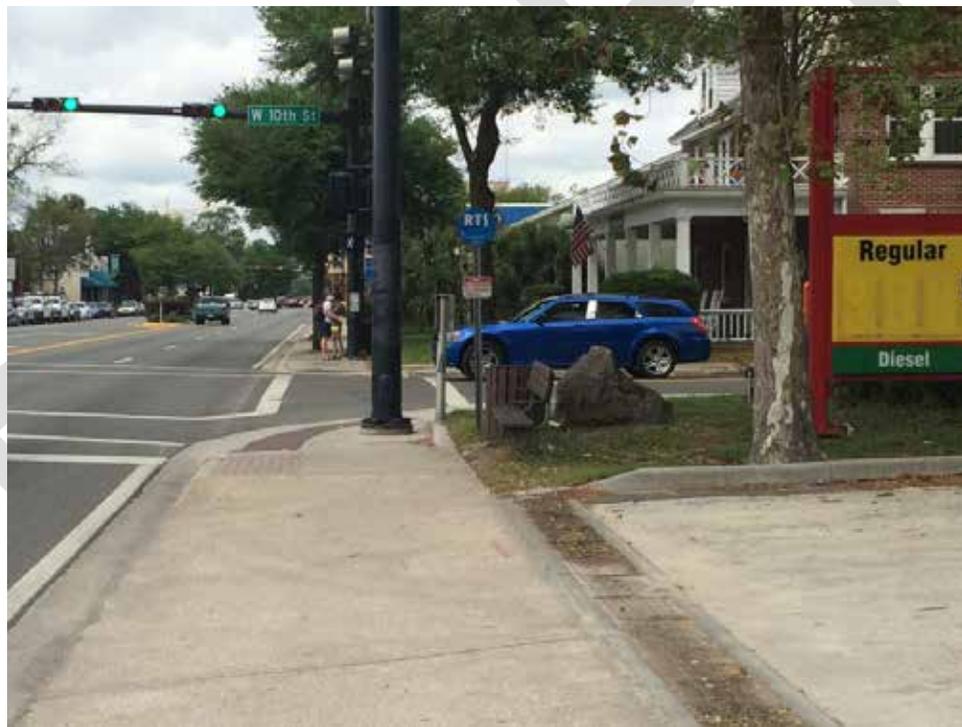
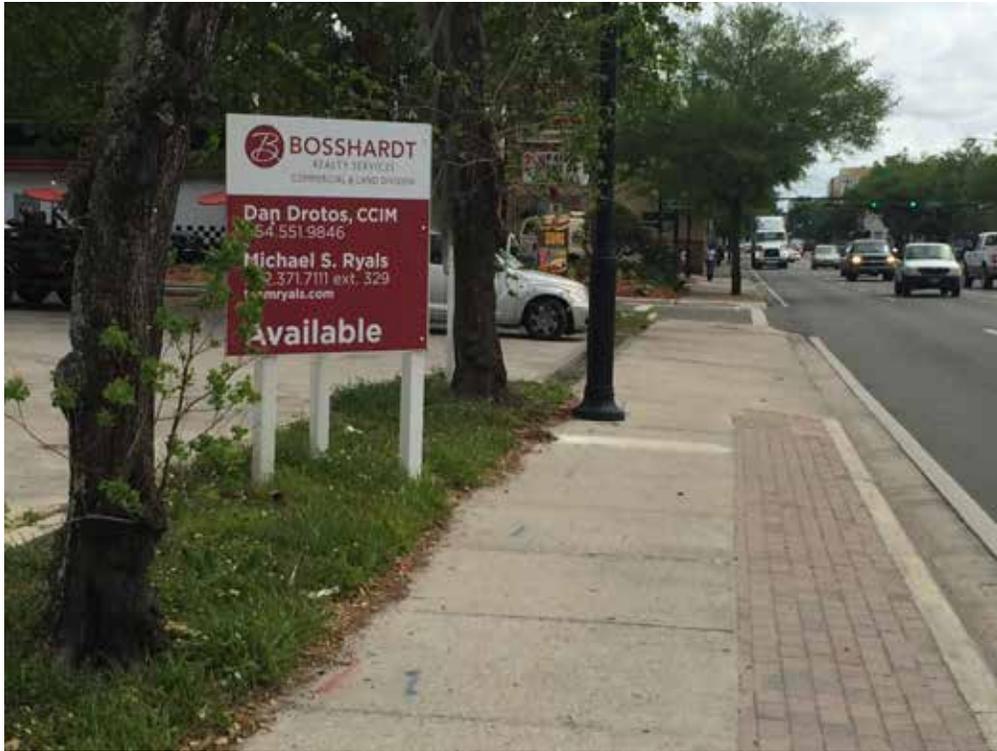
This stop is located next to an overhead light source and thus the level of lighting is adequate. If the stop were to be moved as recommended for the shelter installation, there is another overhead lighting source; however, the roof of the shelter could block the light and the installation of a lighted shelter is recommended.

Figure 25 Photo looking west from RTS stop located on westbound SR 26 at NW 10th Street

Figure 26 Photo looking east between the entering and exiting driveway next to RTS stop located on westbound SR 26 at NW 10th Street

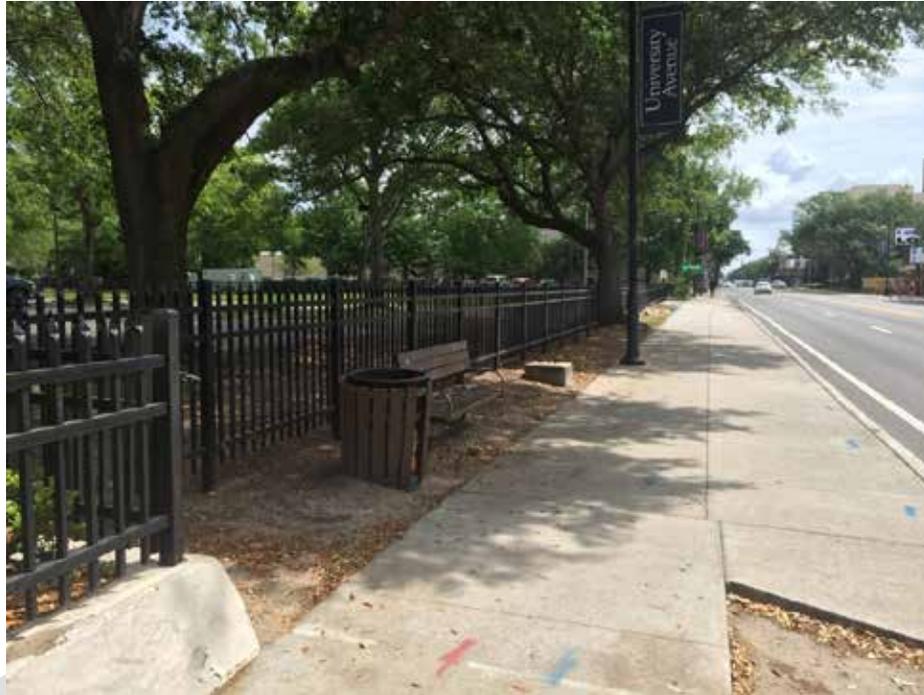
Figure 27 Photo looking east from RTS stop located on westbound SR 26 at NW 6th Street

This stop is located about 15 feet away from the nearest overhead light source. However, the existence of an extensive tree canopy could block the light and the installation of a lighted shelter is recommended.

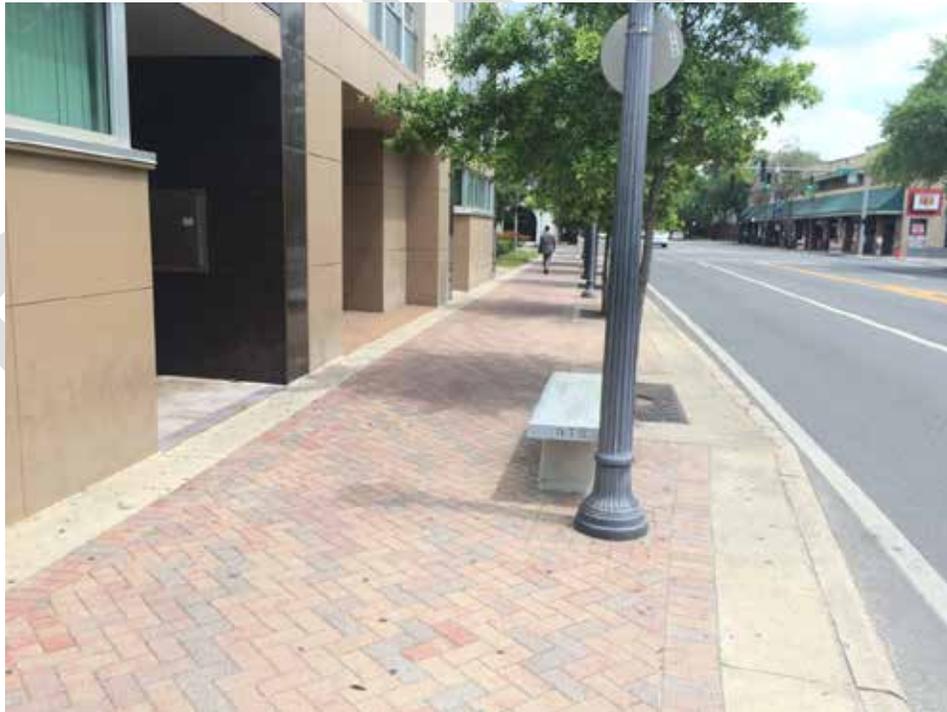
Figure 28 Photo looking east from RTS stop located on westbound SR 26 at NW 1st Street

This RTS stop serves the Office of State Attorney building. The space between the curb and the building is limited as the building edge directly abuts the back of sidewalk, and there is not adequate space for installation of a bus shelter outside of the outer building edge (Figure 28). This stop is located next to an overhead light source; the level of lighting is adequate.

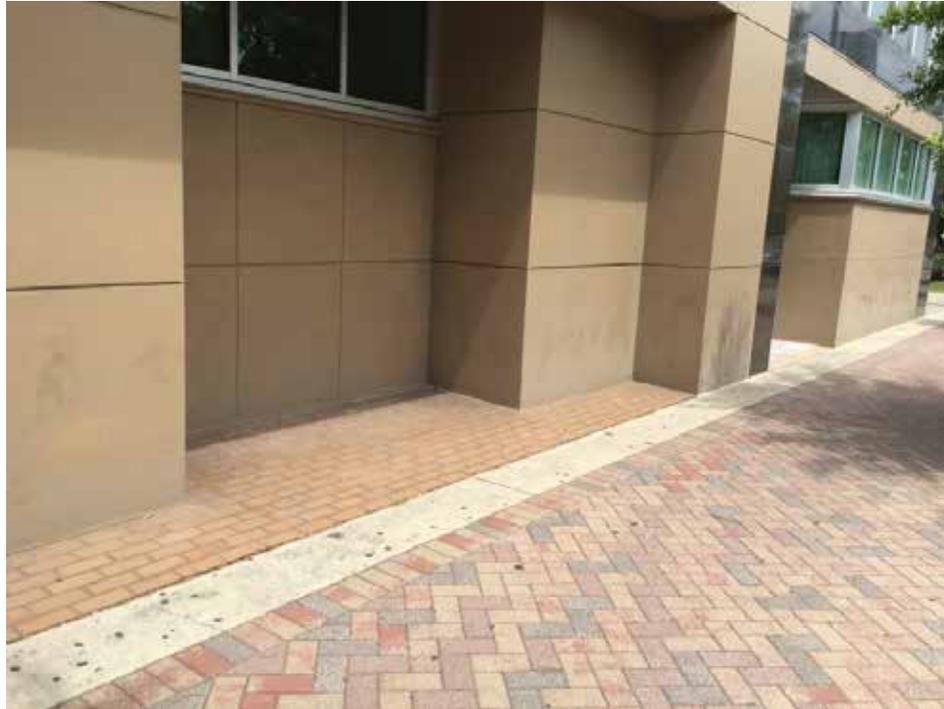
Figure 29 Photo looking east to building opening area next to RTS stop located on westbound SR 26 at NW 1st Street

- Move the bus stop to the east where there is a building opening area of about 9 feet long as shown in Figure 29. However, the spacing is not adequate for the shelter concrete pad required for the smallest RTS shelter. The possibility of hanging an awning off the building should be further evaluated. The awning could block the light and the installation of additional lighting is recommended.

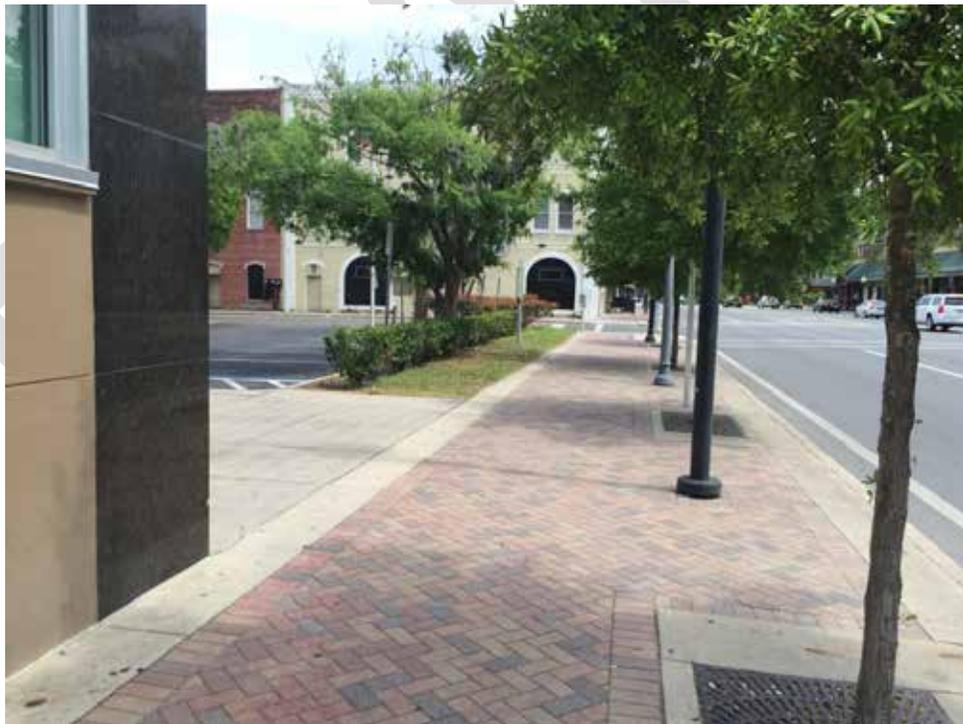
Figure 30 Photo looking east parking lot area next to RTS stop located on westbound SR 26 at NW 1st Street

- Move the bus stop further to the east next to the parking lot area shown in Figure 30. The space between the curb and the parking lot provides the opportunity for the installation of a bus shelter that can extend into the sidewalk if needed. There is an existing historical marker in the grass area that might have to be relocated slightly to the east to accommodate a shelter. There is an overhead light source at this location; however, the roof of the shelter could block the light and the installation of a lighted shelter is recommended.

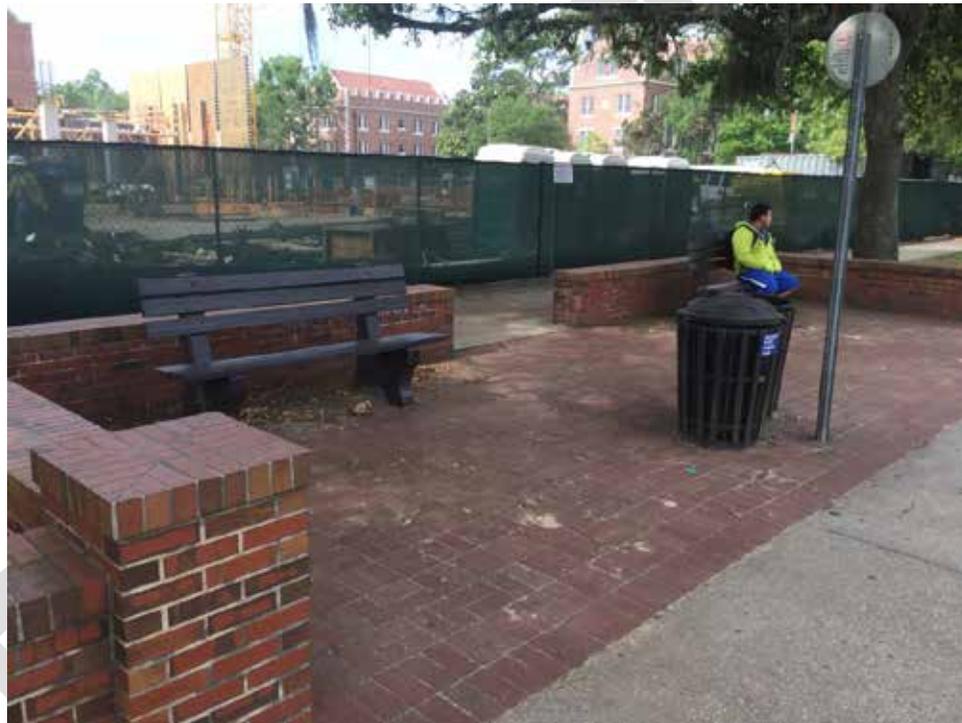
Figure 31 Photo looking west from RTS stop located on eastbound SR 26 at Buckman Drive

This stop is located about 100 feet away from the nearest overhead light source. Therefore, the level of lighting is not adequate and the installation of a lighted shelter is recommended.

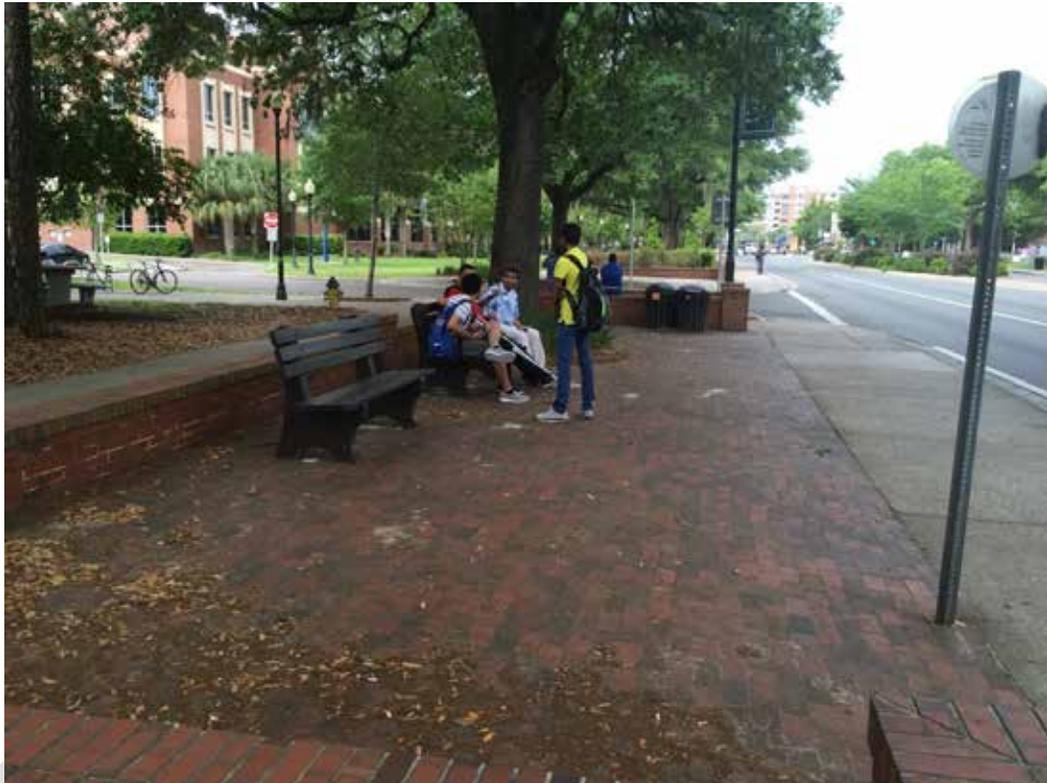
Figure 32 Photo looking west from RTS stop located on eastbound SR 26 at NW 15th Street

This RTS stop serves the University of Florida area (Figure 32). There is a similar opportunity for installation of a bus stop shelter at this location as observed at the RTS stop located on eastbound SR 26 at Buckman Dr.

This stop is located about 12 feet away from the nearest overhead light source but the presence of extensive tree canopy could block the light. Therefore, the installation of a lighted shelter is recommended.

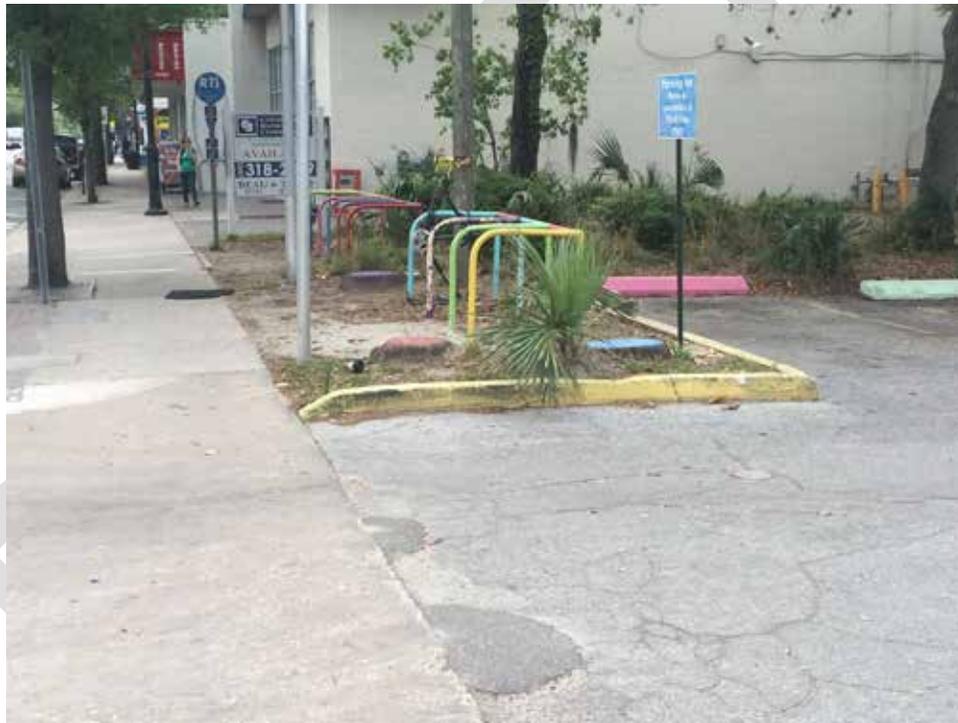
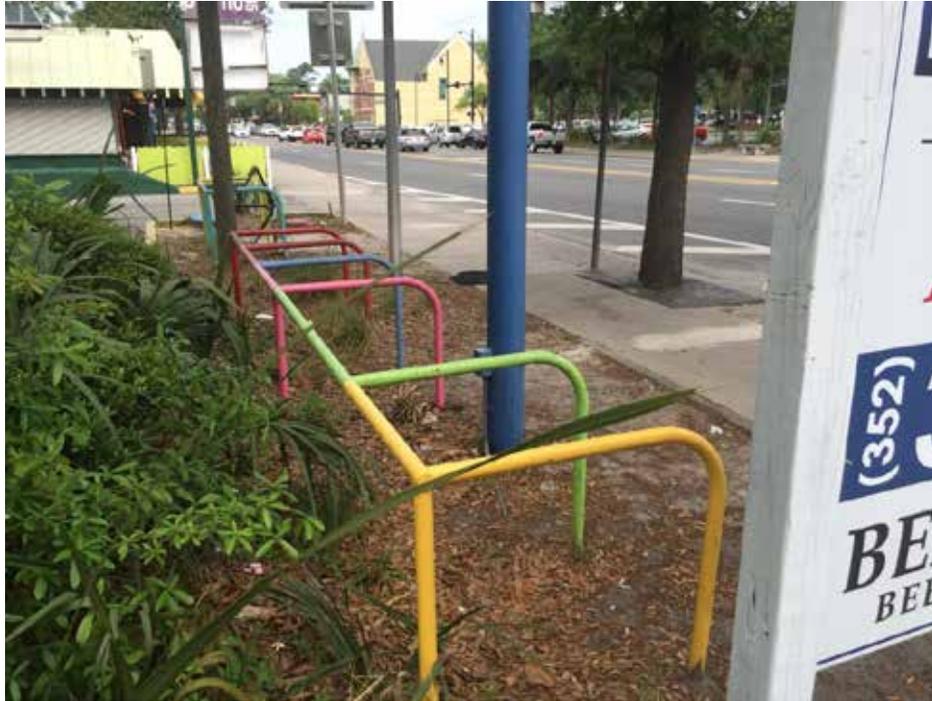
This stop is located about 30 feet away from the nearest overhead light source but the roof of the shelter could block the light. Therefore, the installation of a lighted shelter is recommended.

Figure 33 Photo looking east from RTS stop located on eastbound SR 26 at SW 13th Street

Figure 34 Photo looking west from RTS stop located on eastbound SR 26 at SW 13th Street

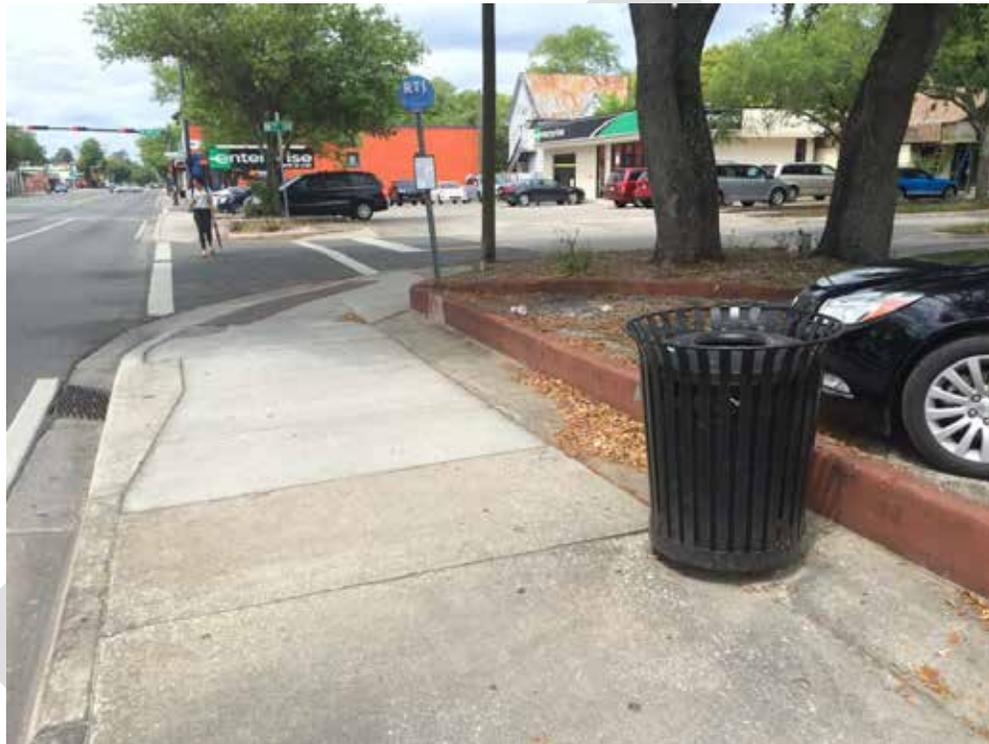
Figure 35 Photo looking west from RTS stop located on westbound SR 26 at NW 7th Terrace

This RTS stop serves a commercial area. There is adequate space within the sidewalk for a bus stop bench placement (Figure 35). Considerations to move the bus stop more towards the east away from the intersection for passenger safety is recommended. RTS indicates the bus currently stops to pick up passengers prior to the RTS bus stop sign; the sign location was chosen because it was the only location that did not require drilling the sign into concrete.

This stop is located about 60 feet away from the nearest overhead light source. Therefore, the level of lighting is not adequate and the installation of a new overhead light source no more than 30 feet from the bus stop is needed.

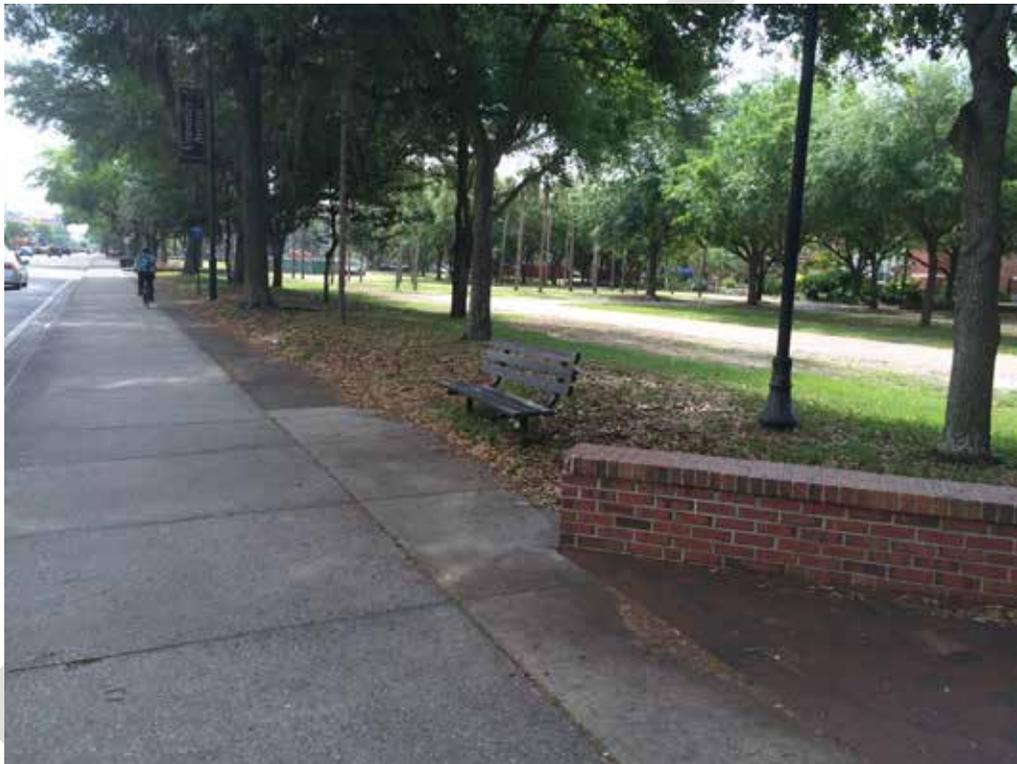
Figure 36 Photo looking east from RTS stop located on eastbound SR 26 at Gale Lemerand Drive

This stop is located about 15 feet away from the nearest overhead light source but the presence of an existing tree canopy could block the light. Therefore, the level of lighting might not be adequate.

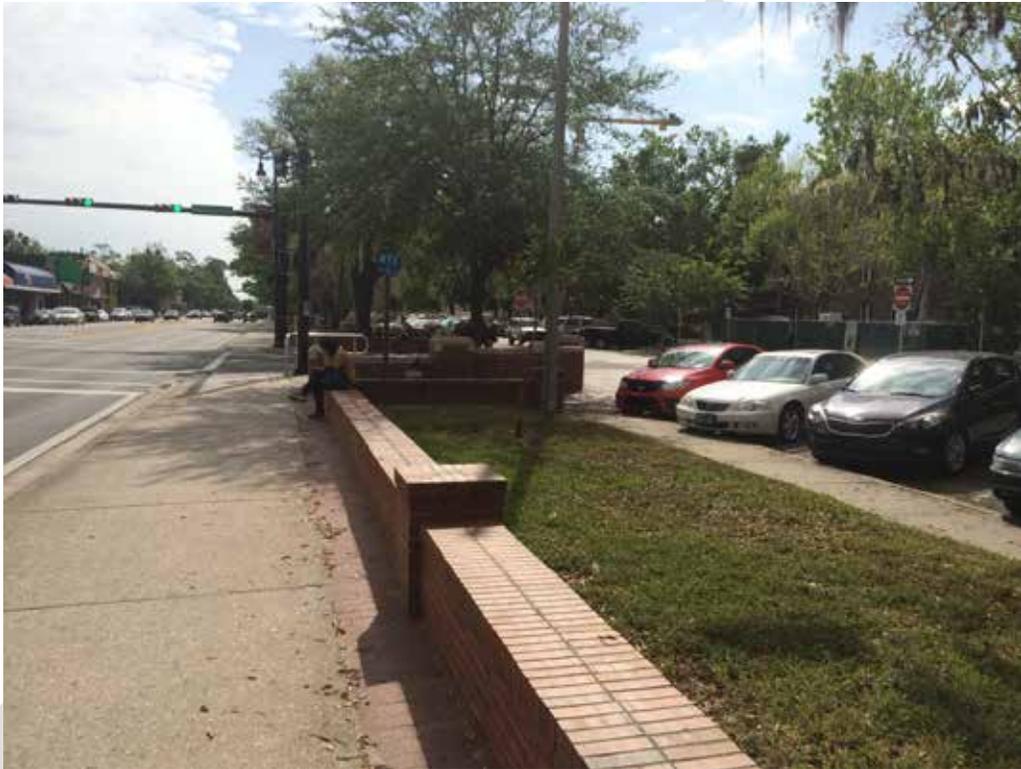
Figure 37 Photo looking east from RTS stop located on eastbound SR 26 at Fletcher Drive

There is an overhead light source located behind to the RTS stop; however, the luminaria is directed to the parking lot area. Therefore, the level of lighting might not be adequate.
