# **SR 26 / University Avenue Multimodal Emphasis Corridor Study**

## **DRAFT Phase 2 Report**

**May 2015**

**Metropolitan Transportation Planning Organization  
for the Gainesville Urbanized Area**

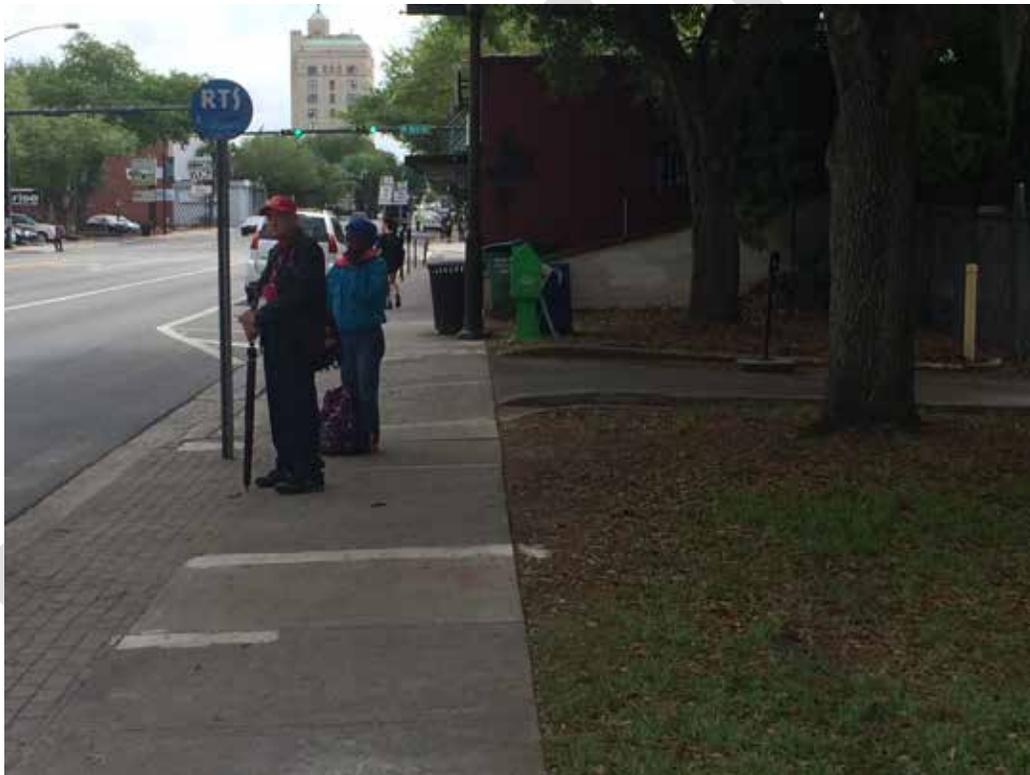
Figure 38 Photo looking east from RTS stop located on eastbound SR 26 at 9th Terrace

This stop is located about 30 feet away from the nearest overhead light source. Therefore, the level of lighting is adequate.
