# **DRAFT Existing Conditions Report**

Metropolitan Transportation Planning Organization for the Gainesville Urbanized Area

The Metropolitan Transportation Planning Organization (MTPO) for the Gainesville Urbanized Area is conducting the first phase of a Multimodal Emphasis Corridor Study for State Road 26 (University Avenue) between Gale Lemerand Drive and Waldo Road. The purpose of this study is to identify specific multimodal projects within this 2.3-mile portion of SR 26 that can be programmed for implementation by the Florida Department of Transportation (FDOT) in its Five-Year Work Program. Phase 1 of the study will include a preliminary review and

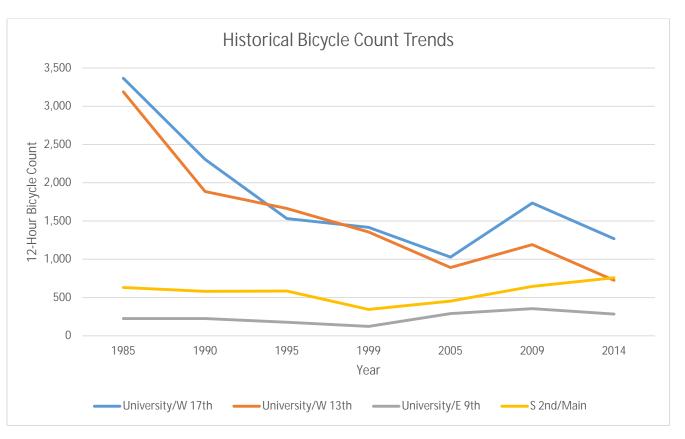
This trend graph illustrates that the two count locations adjacent to the UF campus demonstrate an overall downward trend since 1985, although most of that decline occurred during the first of the three intervening decades. [The report notes that these two locations are consistently amongst the highest bicycle volumes collected throughout Alachua County.] The count location that represents the eastern portion of the study corridor demonstrates the opposite trend, with bicycle volumes generally on the rise since 1999. Three of the four locations experienced a decline in volume between 2009 and 2014, with the exception being the site along S 2<sup>nd</sup> Avenue. The *2014 Bicycle Usage Trends Report* contains additional details, including all years collected and intersection bicycle turning movements for the 2014 counts.

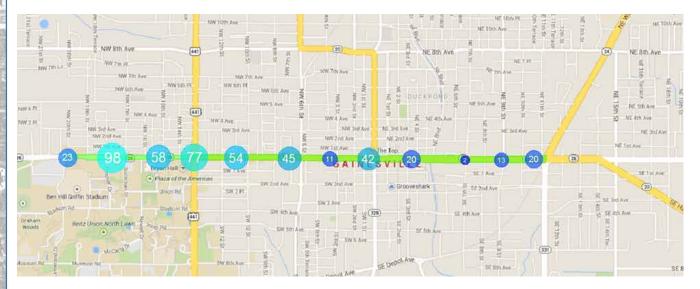
Motor vehicle crash trends were analyzed in the study area for the three year period from September 1, 2011 to August 31, 2014. Crash data was provided by the University of Florida GeoPlan Center's Signal Four Analytics. Four-hundred and sixty-three (463) total crashes were reported, with 17 crashes involving a bicyclist and 23 crashes involving a pedestrian. A map of the study area is shown below with predominant crash locations identified.

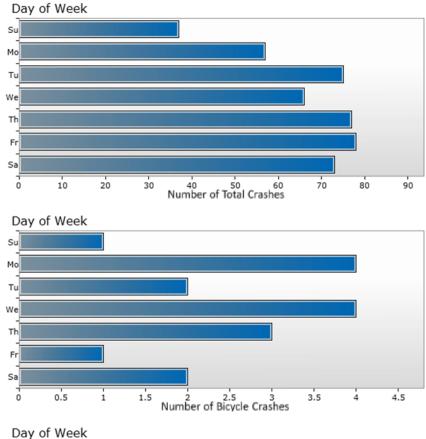
The most bicycle crashes occurred on Monday and Wednesday while the most pedestrian crashes occurred on Thursday and Saturday. Only 17 bicycle crashes occurred compared to 23 pedestrian crashes. In both cases, prominent conclusions are difficult to draw due to such a small sample size.

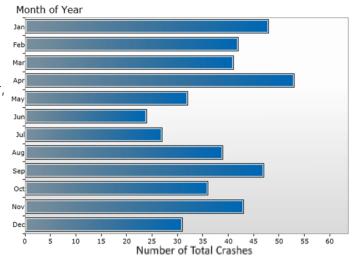
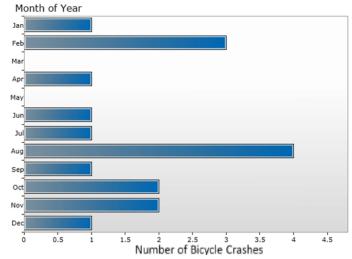
Month of Year

The total number crashes by month of year reveals that April experienced the most crashes, followed by January and September. Crashes are least frequent in the summer month and in December, months when campus activity is generally lightest.

Bicycle and pedestrian crashes do not show discernable seasonal trends.

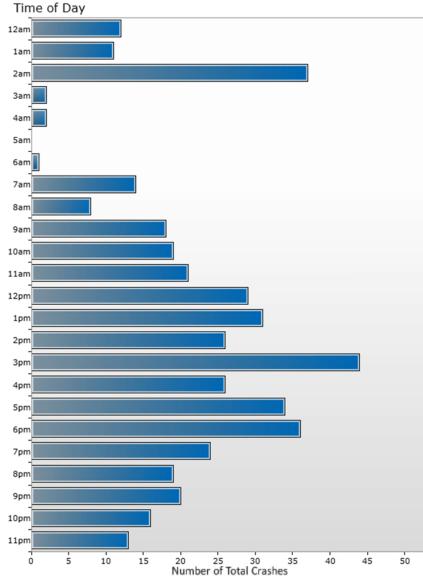
The most number of crashes occurred Tim during the 3pm hour. There is a general increase in crashes from the late morning until a peak in the afternoon followed by a drop-off into the late evening hours.

A noticeable spike in crashes occurred during the 2am hour. This spike may be explained by the corridor featuring numerous night-time entertainment venues and bars.

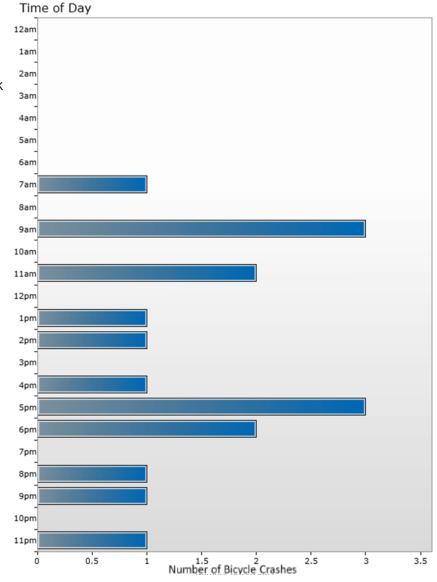
Bicycle crashes occurred sporadically between 7:00am and midnight. While the sample size is small, the greatest number of bicycle crashes occurred during the morning and afternoon peak travel periods.

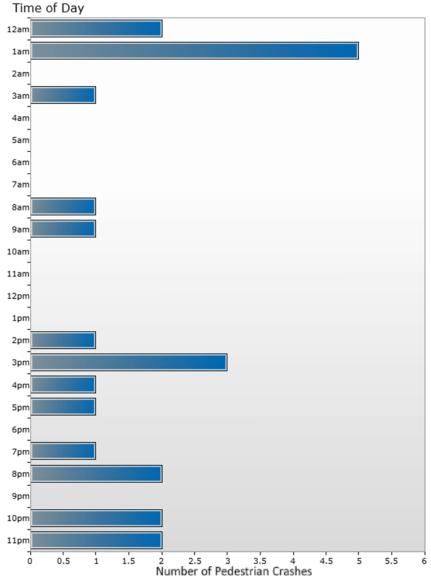
The highest number of pedestrian crashes occurred during the 1am hour. This can likely be explained similarly to the early morning peak seen in the total crashes by time of day analysis. Interestingly, more pedestrian crashes occurred between the hours of 7pm-7am (14) then during daylight hours between 7am-7pm (9). This might suggest inadequate lighting conditions. However, there is a much stronger correlation between pedestrian crashes and the involvement of alcohol compared to lighting conditions. This correlation will be explored later in this report.

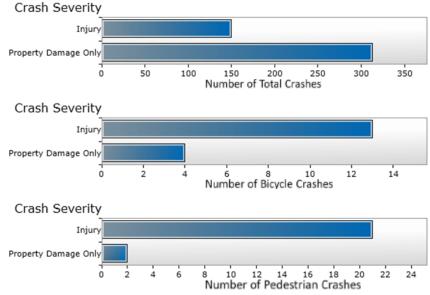
Out of 463 total crashes, 150 crashes occurred in which at least one injury was reported (32%). This figure is skewed slightly by the inclusion of bicycle and pedestrian crashes. There were 216 injuries reported altogether, and 43 crashes resulted in more than one injury.

This high number of crashes resulting in multiple injuries could be the result of one or more of the following: crashes involving higher speeds, crashes where multiple parties are at fault, and crashes involving motor vehicles occupied by multiple persons. Crashes involving motor vehicles occupied by multiple persons likely have the greatest impact on the number of crashes resulting in more than one injury. This is especially true if those involved were not wearing a safety harness.

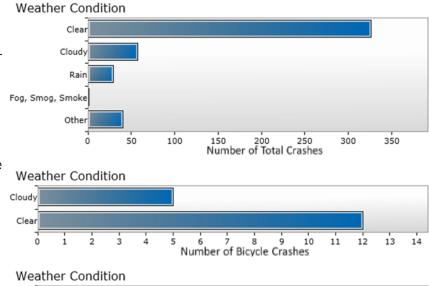
Of the 463 reported crashes, 383 (83%) occurred during clear or cloudy weather conditions. Rain was involved in only 29 crashes, and 40 crashes involved a condition other than what is listed.

All 17 bicycle crashes occurred during clear or cloudy weather conditions. The lack of crashes in other conditions is likely tied to a reduction in the volume of bicycling activity during adverse weather conditions.

Of the 23 reported pedestrian crashes, only two involving rainy weather conditions occurred. Similarly to crashes involving bicyclists, this low figure is likely tied to a reduction in pedestrian traffic during adverse weather conditions, though perhaps not to the same degree.

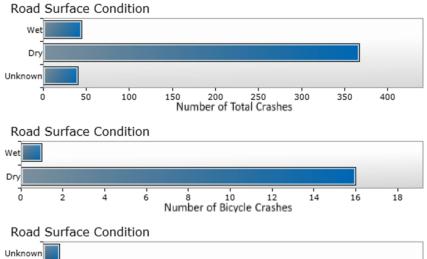
Road surface condition had seemingly minimal impact on the majority of reported crashes. Most crashes involved a dry road surface. Of the 463 total crashes, only 45 (10%) involved a wet road surface while 41 crashes involved an unknown road surface.

A wet road surface was involved in a similarly low number of bicycle and pedestrian crashes. This is likely tied to a reduction in the volumes of bicycle and pedestrian traffic during adverse weather conditions.

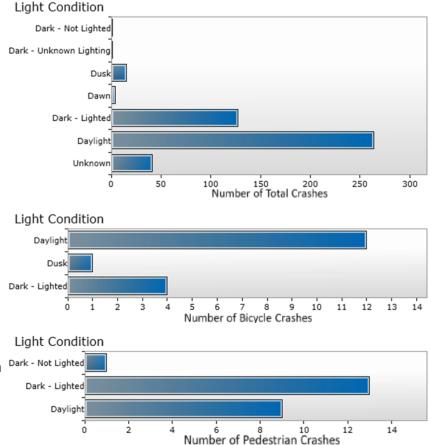
Of the 463 total reported crashes, 264 (57%) occurred during daylight conditions. An additional 127 occurred in dark-lighted conditions, while 41 crashes occurred during unknown lighting conditions. Significantly more crashes occurred at dusk (15) than at dawn (four). Only one crash occurred during dark-not lighted conditions. A single crash occurred during darkunknown lighting conditions as well.

Similar trends can be observed for bicycle crashes, with the majority occurring during daylight hours.

Pedestrian crashes occurred mostly during dark-lighted conditions. This supports previous data that indicates an increase in pedestrian crashes between the hours of 7pm-7am.

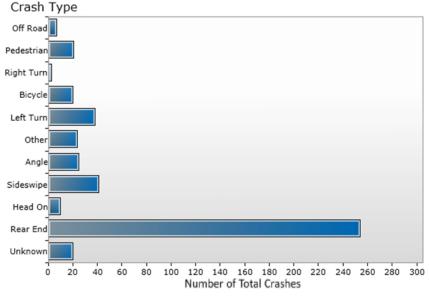
These trends suggest that most crashes occurred as the result of an at-fault driver following too close or being inattentive. A relatively high number of sideswipe collisions suggests an at-fault driver who either misjudged a clearance or was inattentive. Left turn and angle collisions suggest a failure to yield on the part of the at-fault driver.

Only ten collisions were head on, while only seven crashes occurred off the roadway. These types of crashes are typically more severe. This correlates highly with the relatively low number of injuries and complete absence of fatalities.

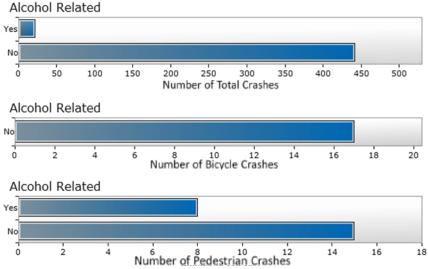
Of the eight pedestrian crashes reported as involving alcohol, four occurred during the 1am hour. Two occurred during the 8pm hour while 2pm and 11pm also had a pedestrian crash. Only one crash resulted in a D.U.I. for the driver. While alcohol was involved in eight crashes, the pedestrian who was struck was suspected to be under the influence in six of the crashes. More often than not, the pedestrian was witnessed as standing in the middle of the road or suddenly darting into traffic. According to multiple Florida Traffic Crash *Reports*, pedestrians were commonly struck outside of a designated crosswalk.

Note that crashes may be reported as alcohol related if either person involved is *suspected* of being under the influence. Categorization as alcohol related does not necessarily mean that a D.U.I. was issued for the driver or a citation for the pedestrian.

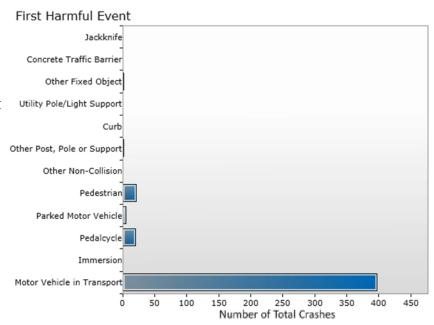
By far the most common first harmful event was motor vehicle in transport (86%). This indicates that the initial event of a crash was due to contact between two travelling motor vehicles. Other than bicycle and pedestrian crashes, the only other first harmful event reported in more than two crashes was parked motor vehicle.

A lack of first harmful events with fixed objects suggests a few important details about the roadway on which these crashes occurred. This low number of crashes with fixed objects suggests that University Avenue is well designed both in terms of geometry and speed limit. Thus, drivers typically have ample time and space to anticipate and react to events occurring within the roadway.
