SR 26 / University Avenue Multimodal Emphasis Corridor Study

Phase 2 Report

June 1, 2015

**Metropolitan Transportation Planning Organization
for the Gainesville Urbanized Area**

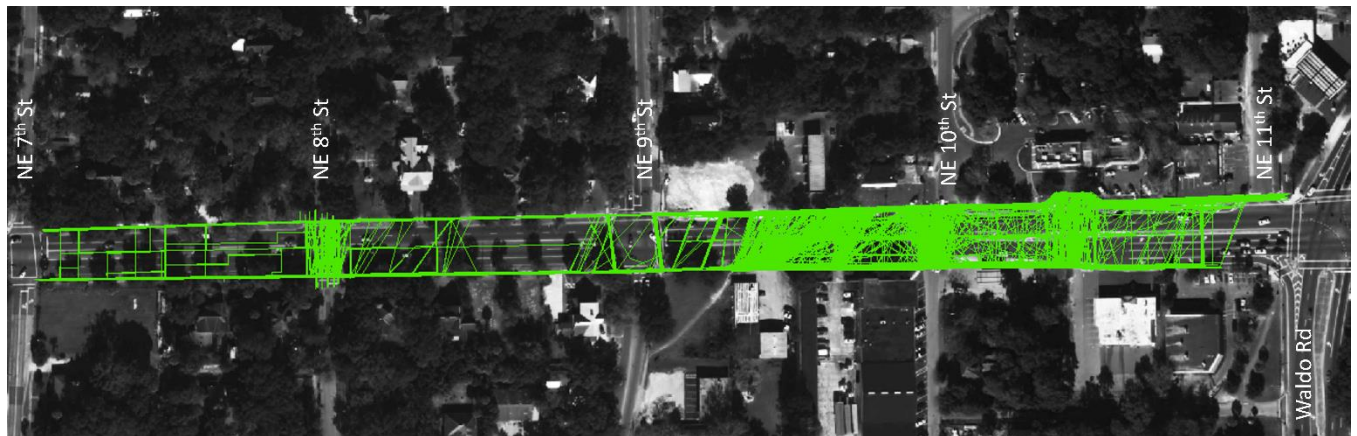
Figure 4 Pedestrian Paths Mapped between E 7th St and Waldo Rd

SR 26 from E 7th Street to the beginning of the raised median east of 10th Street was video recorded to map pedestrian movements. Data was collected for the Thursday, Friday, and Saturday, February 5-7, 2015. Visibility during the 0:00-2:00 hours on February 5th were sub-optimal due to rain. 1,340 pedestrian movements in which pedestrians crossed SR 26 were mapped (Figure 4). These pedestrian crossings fell into several categories.

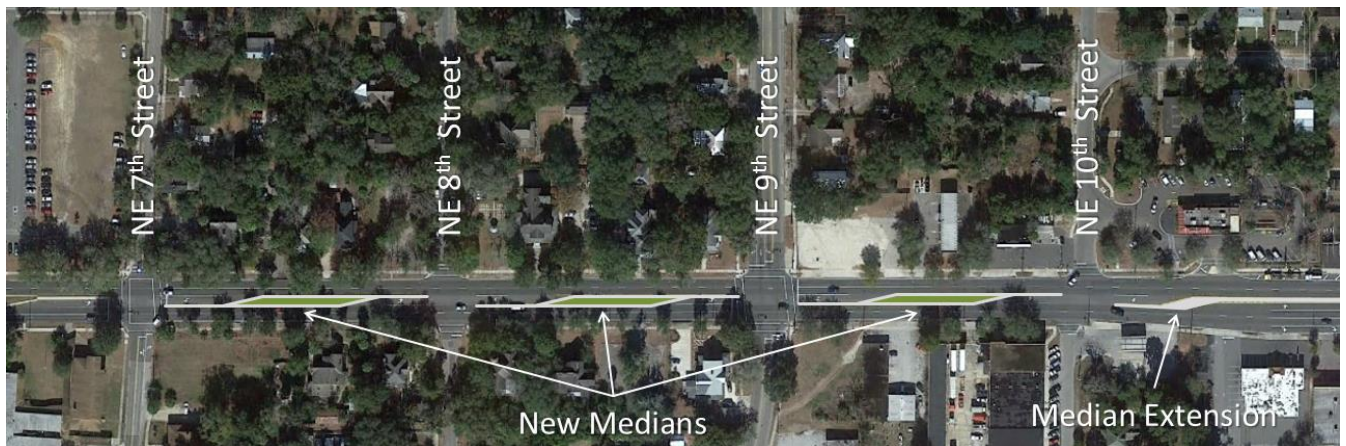
Figure 8 Recommended Medians between 7th Street and 10th Street

Given the above, a raised median is recommended to be installed between E 7th Street and the existing median east of E 10th Street. Between E 7th Street and E 9th Street, the FDOT Straight Line Diagram indicates this section of roadway has four 12-foot lanes and a 13-foot painted turn lane. Narrowing the travel lanes to 11 feet would allow for the provision of a 17-foot median where there are currently two-way left turn lanes and a 6-foot traffic separator where there are dedicated left turn lanes (which would be 11 feet wide). The 2015 revision of the FDOT *Plans Preparation Manual* (Table 2.1.1) specifies lane widths of 11 feet for divided urban arterials with design speeds of 45 mph or less. East of E 10th Street the median could widen to encompass the current painted median (Figure 8). The existing and proposed cross sections are shown in Figure 9.

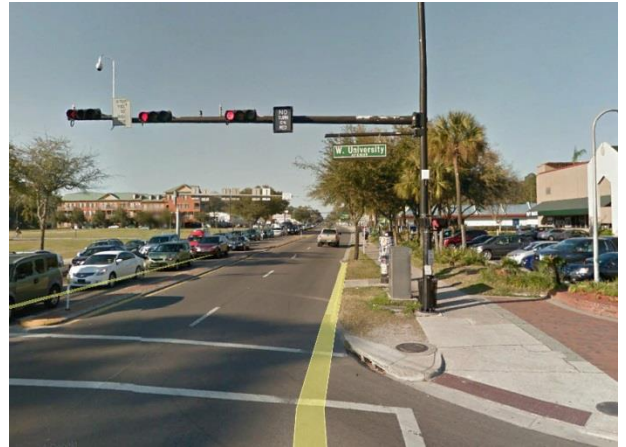
Figure 12 No RIGHT ON RED Blank Out Sign at SR 26 and 13th Street

NO RIGHT ON RED blank out signs are installed at the signalized intersections of SR 26 with Main Street and 13th Street (Figure 12). During certain periods these signs are activated (lit) every cycle. However, during off peak periods they are not activated.

Allowing activation of the blank out signs when the corresponding pedestrian buttons are pushed would allow for this restriction while not prohibiting right turn on red when pedestrians are not present. Discussions with City of Gainesville traffic engineering staff suggests that while it is not trivial to reprogram the controllers for this type of on-demand blank-out sign operating, it is possible at these intersections. The implementation of this improvement would require City staff to reprogram the controllers. If implemented, pre- and post-implementation compliance rates should be evaluated.

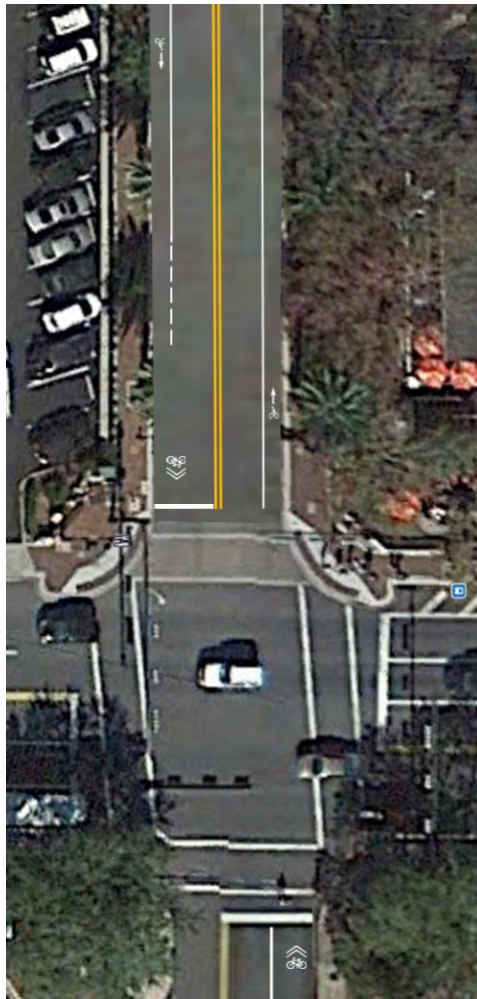
Figure 14 Potential Markings for NW 17th Street and SW 17th Street

The recommendation for this location is for the bike lane to be terminated in advance of the intersection and SHARED LANE MARKINGS installed on the final approach. Alternatively, the BICYCLE DETECTOR could be used instead of a SHARED LANE MARKING. Both the north and south approaches could have either marking placed at the intersection to both inform the bicyclists of where to place their bicycles to be detected by the signals and to encourage them to move their bicycles further into the through lanes. This marking pattern is shown in Figure 14. The SHARED LANE MARKING may be more familiar to Gainesville residents and thus be a better symbol to use.

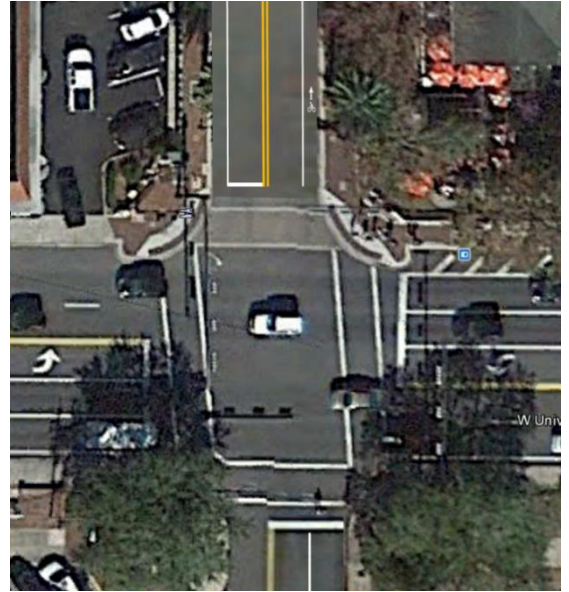
Figure 13 NW 17th Street and University Existing Markings

The northern approach to this intersection has the bike lane striped all the way to the stop

line. This solid-stripe-to-the-intersection striping is inconsistent with the MUTCD, the AASHTO *Bike Guide*,⁵ and the Florida *Greenbook*.⁶ Also, a solid line separating the bike lane from the general lane at an intersection discourages motorists from approaching the intersection and turning right from “as close as practicable to the right-hand curb or edge of roadway.”⁷ This movement to the right is required by Florida’s uniform traffic laws. It also encourages bicyclists making a through movement to stay on the right side of the pavement all the way up to the intersection. The combination of these behaviors encourages “right hook” type conflicts. The (approximate) existing striping is shown in Figure 13.

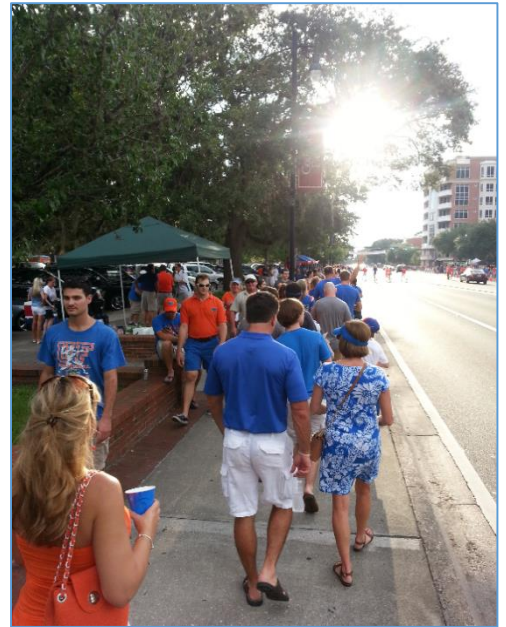
Figure 16 Pedestrian Traffic along SR 26 on a Game Day

The south side of SR 26 between Gale Lemerand Drive and W 13th Street generally forms the northern boundary of the University of Florida and is an area of particularly high east-west bicycle and pedestrian activity, primarily consisting of student travel. This section of SR 26 provides non-motorized access to Ben Hill Griffin Stadium, the O'Connell Center, Library West, and multiple residence halls and classroom buildings, and also provides crossing access to key destinations on the north side of SR 26. The existing configuration of this section includes an 8-foot sidewalk located directly at the back of curb. The majority of the section also includes a second sidewalk-like facility, separated from the other sidewalk by a low brick wall and a planting strip that is located on University property. Given the lack of comfortable bicycle accommodation within University Avenue itself, each of these facilities experiences a heavy mix of bicycle and pedestrian travel, with many conflicts between the modes. This is especially true during peak travel, including on football and basketball game days, and frequently leads to the functional capacity of the sidewalk being exceeded (Figure 16).

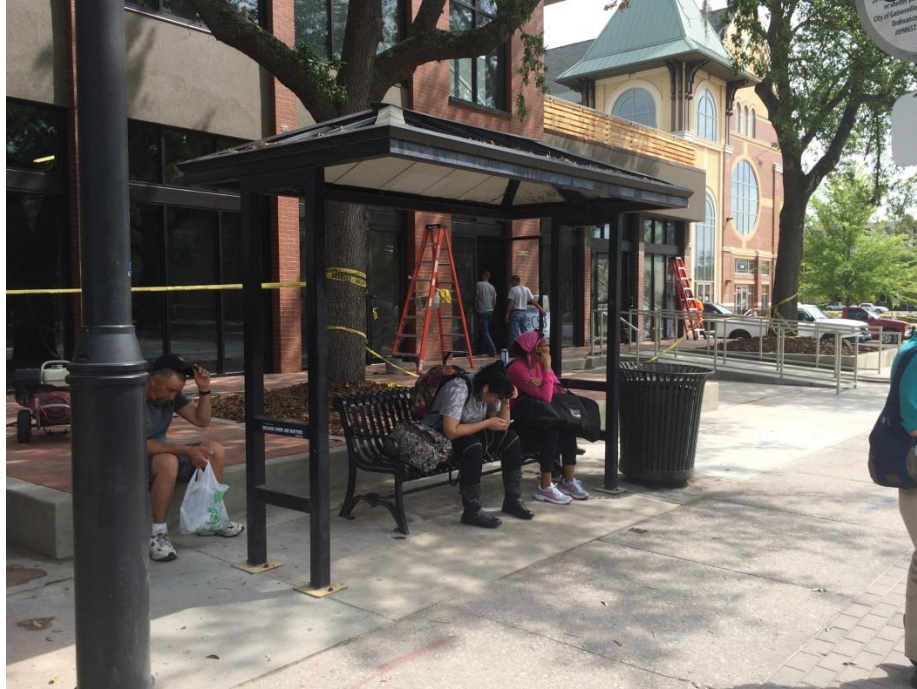
Figure 20 Photo of existing shelter at RTS stop located on westbound SR 26 at NW 14th Street

Figures 20 and 21 show typical configurations of a small RTS bus stop shelter.

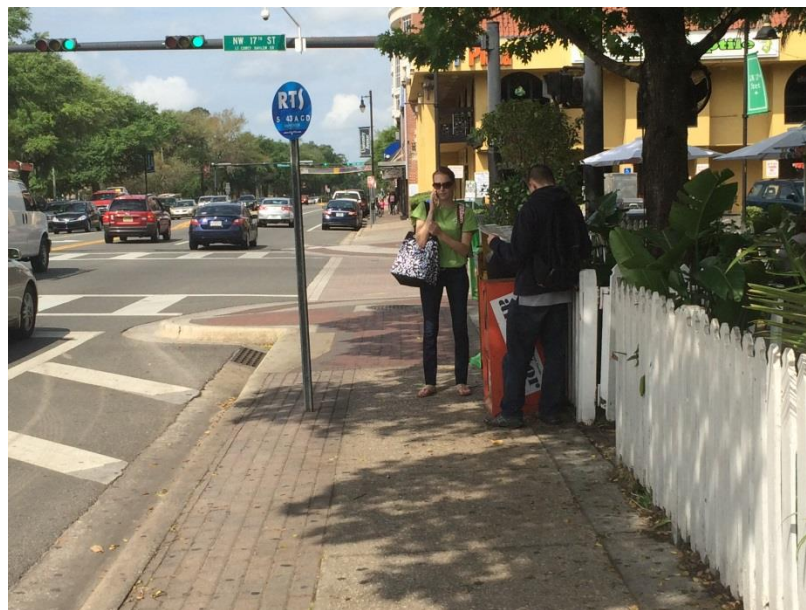
Figure 23 Photo looking west from RTS stop located on westbound SR 26 at NW 17th Street

This stop is located about 80 feet away from the nearest overhead light source. There is no opportunity, with the existing stop layout, to locate the stop closer to the overhead light due to the proximity to the crosswalk and intersection. Therefore, the level of lighting is not adequate and the installation of a lighted shelter is recommended.

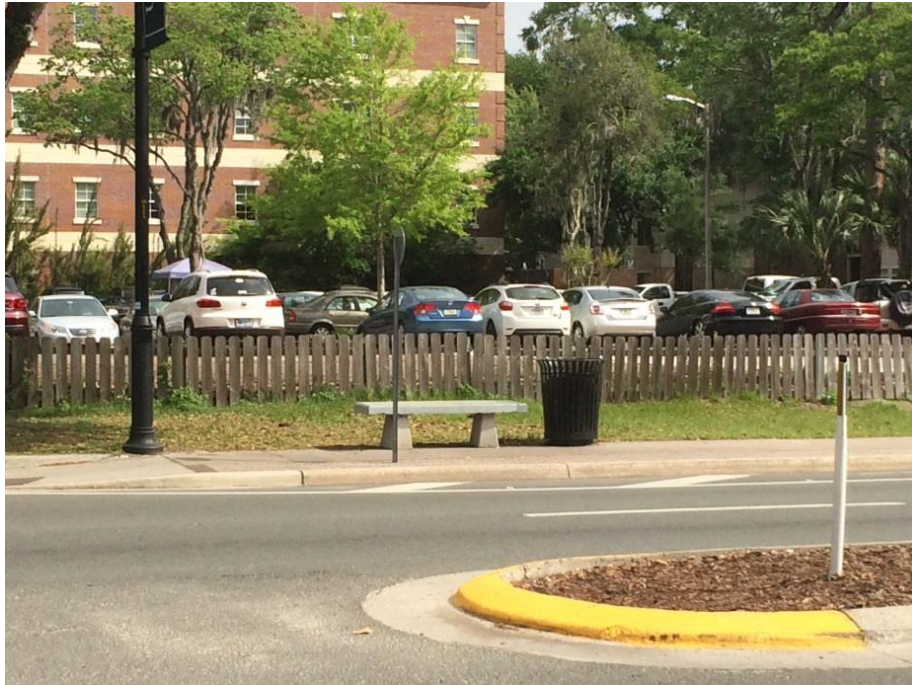
Figure 24 Photo looking north from across SR 26 to RTS stop located on westbound SR 26 at NW 16th Street

This stop is located about 10 feet away from the nearest overhead light source. However, the roof of the shelter could block the light and the installation of a lighted shelter is recommended.

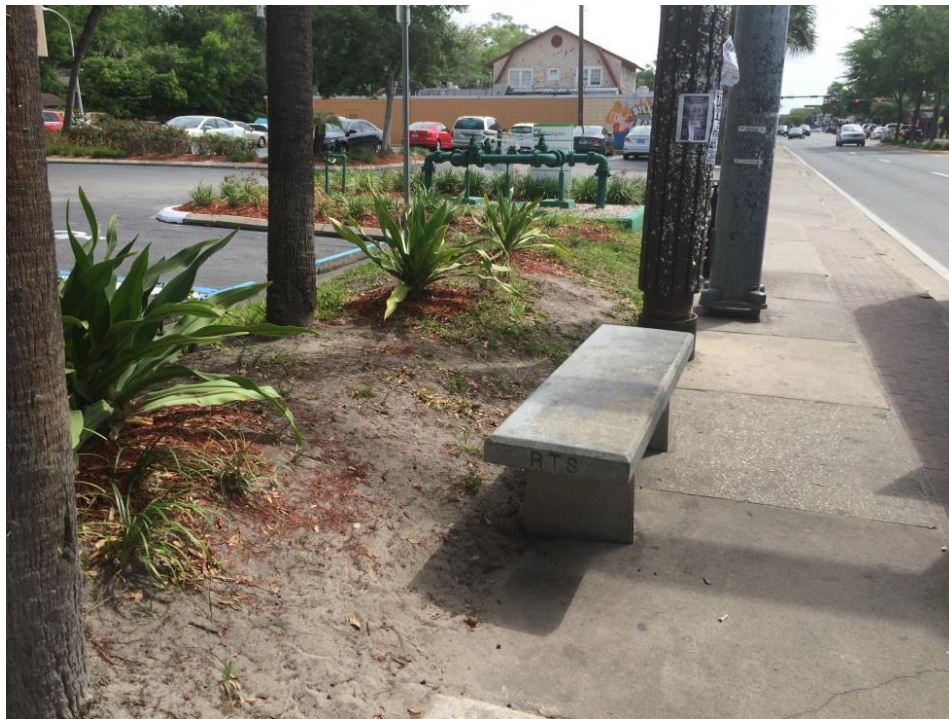
Figure 25 Photo looking east from RTS stop located on westbound SR 26 at NW 13th Street

This stop is located about 30 feet away from the nearest overhead light source. However, the roof of the shelter could block the light and the installation of a lighted shelter is recommended.

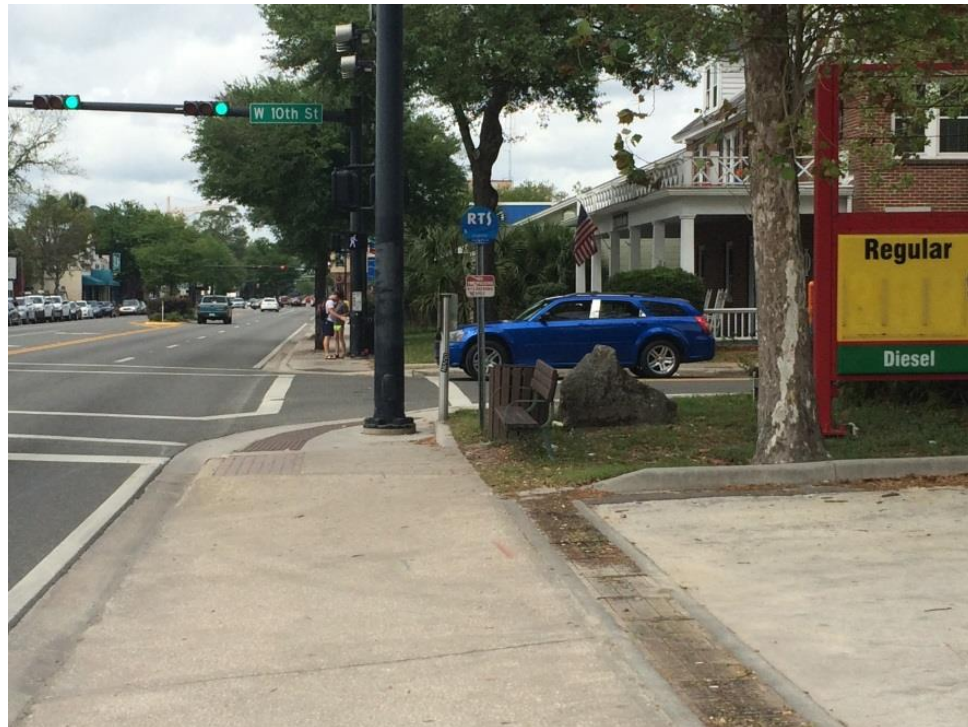
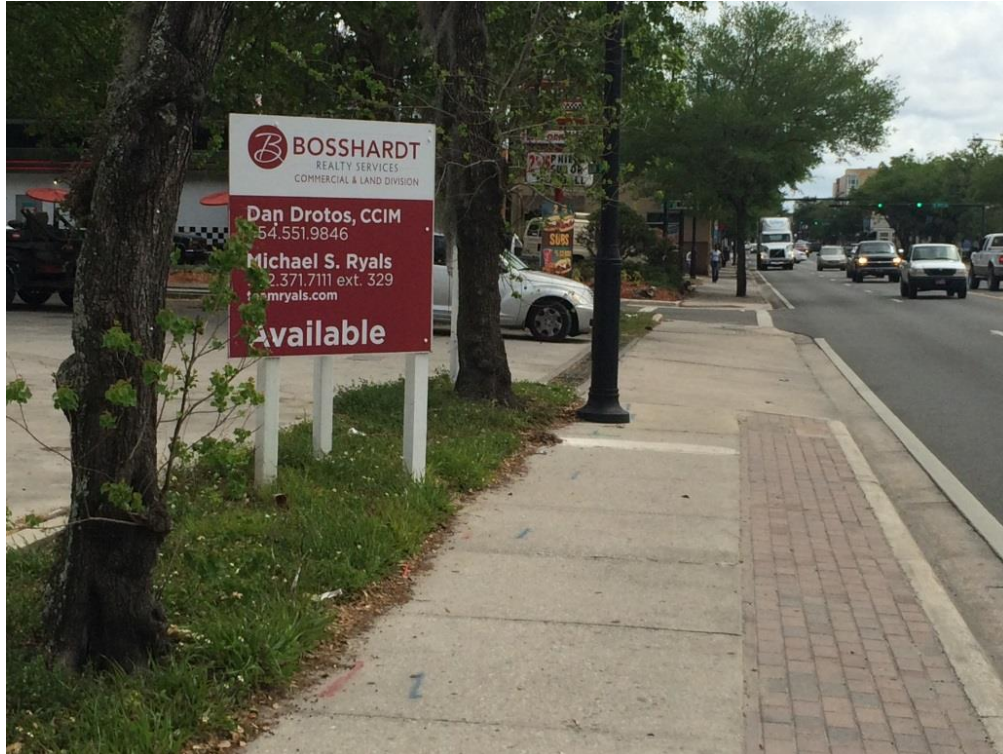
Figure 26 Photo looking west from RTS stop located on westbound SR 26 at NW 10th Street

This stop is located next to an overhead light source and thus the level of lighting is adequate. If the stop were to be moved as recommended for the shelter installation, there is another overhead lighting source; however, the roof of the shelter could block the light and the installation of a lighted shelter is recommended.

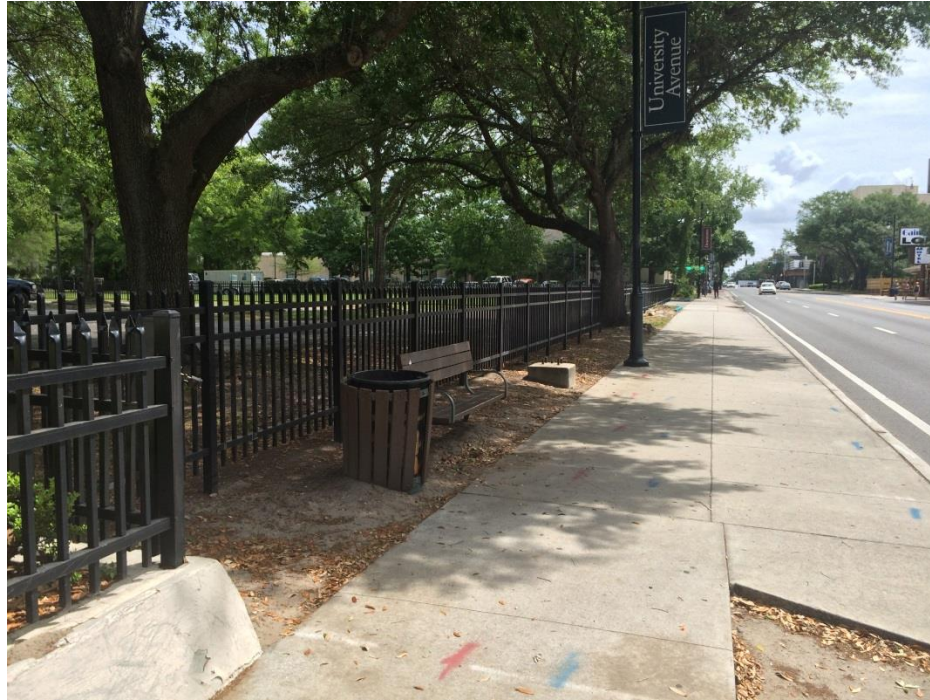
Figure 28 Photo looking east from RTS stop located on westbound SR 26 at NW 6th Street

This stop is located about 15 feet away from the nearest overhead light source. However, the existence of an extensive tree canopy could block the light and the installation of a lighted shelter is recommended.

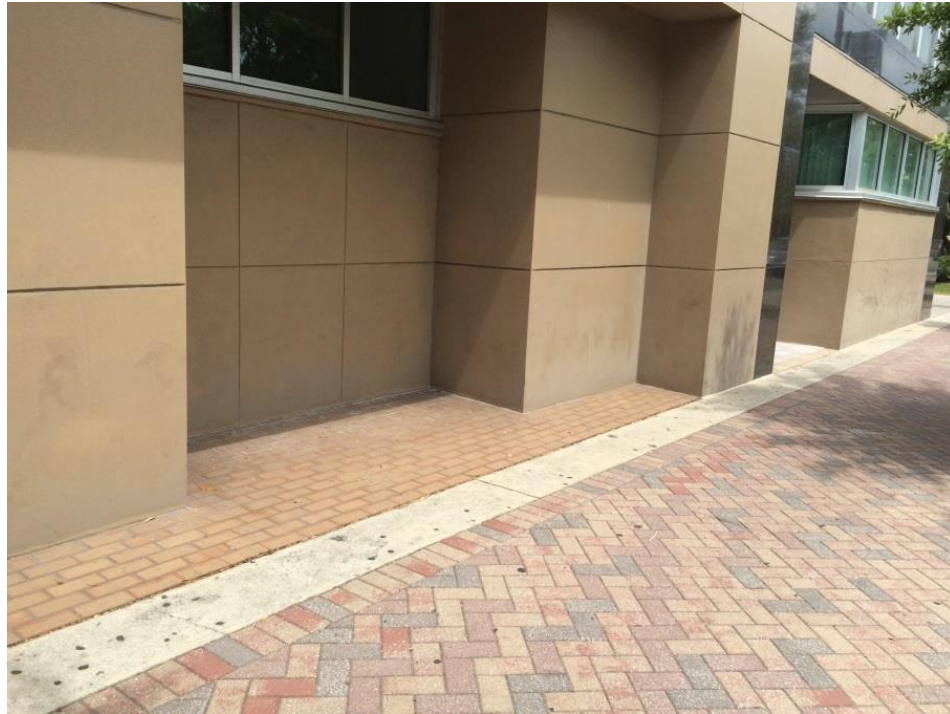
Figure 30 Photo looking east to building opening area next to RTS stop located on westbound SR 26 at NW 1st Street

- Move the bus stop to the east where there is a building opening area of about 9 feet long as shown in Figure 30. However, the spacing is not adequate for the shelter concrete pad required for the smallest RTS shelter. The possibility of hanging an awning off the building should be further evaluated. The awning could block the light and the installation of additional lighting is recommended.

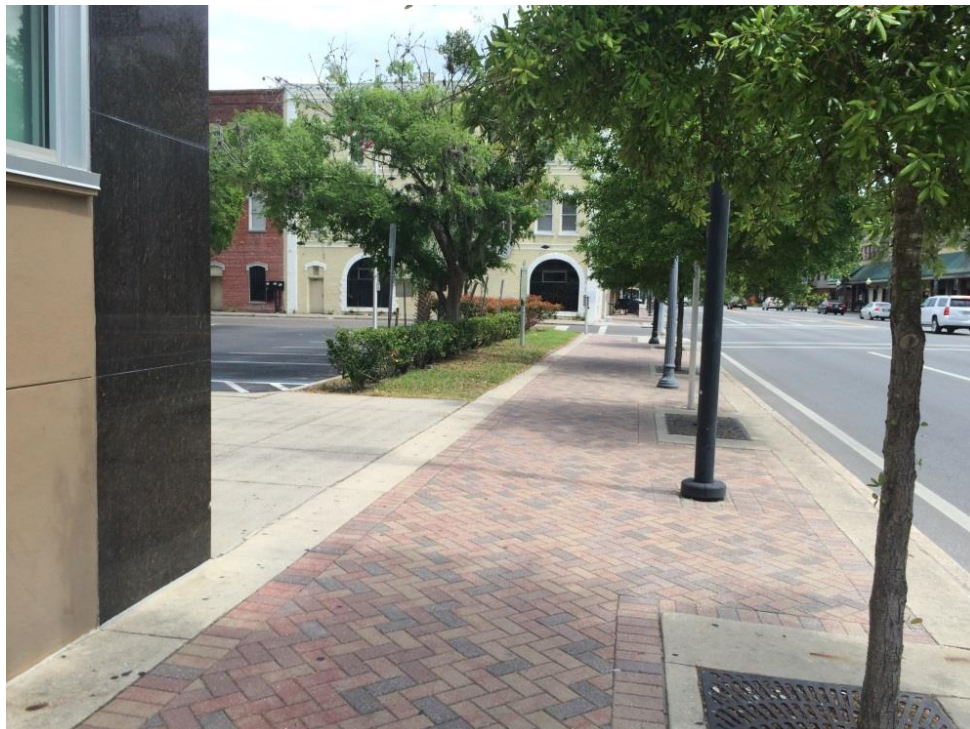
Figure 31 Photo looking east parking lot area next to RTS stop located on westbound SR 26 at NW 1st Street

- Move the bus stop further to the east next to the parking lot area shown in Figure 31. The space between the curb and the parking lot provides the opportunity for the installation of a bus shelter that can extend into the sidewalk if needed, which could require an easement. There is an existing historical marker in the grass area that might have to be relocated slightly to the east to accommodate a shelter; there is sufficient curb space to accommodate a bus at this new location. There is an overhead light source at this location; however, the roof of the shelter could block the light and the installation of a lighted shelter is recommended.

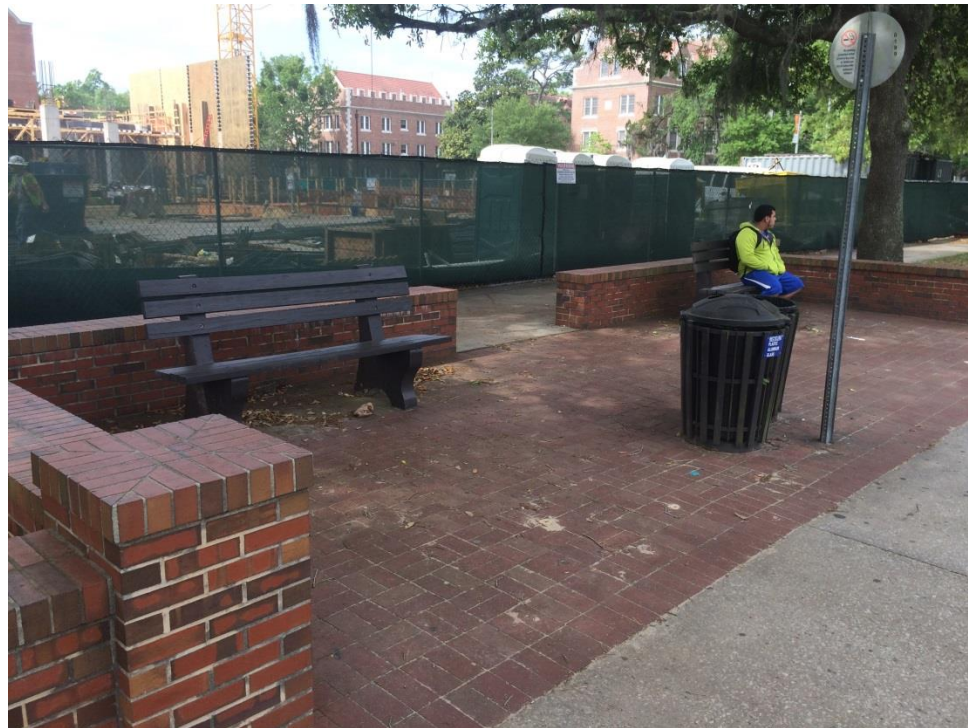
Figure 32 Photo looking west from RTS stop located on eastbound SR 26 at Buckman Drive

This stop is located about 100 feet away from the nearest overhead light source. Therefore, the level of lighting is not adequate and the installation of a lighted shelter is recommended.

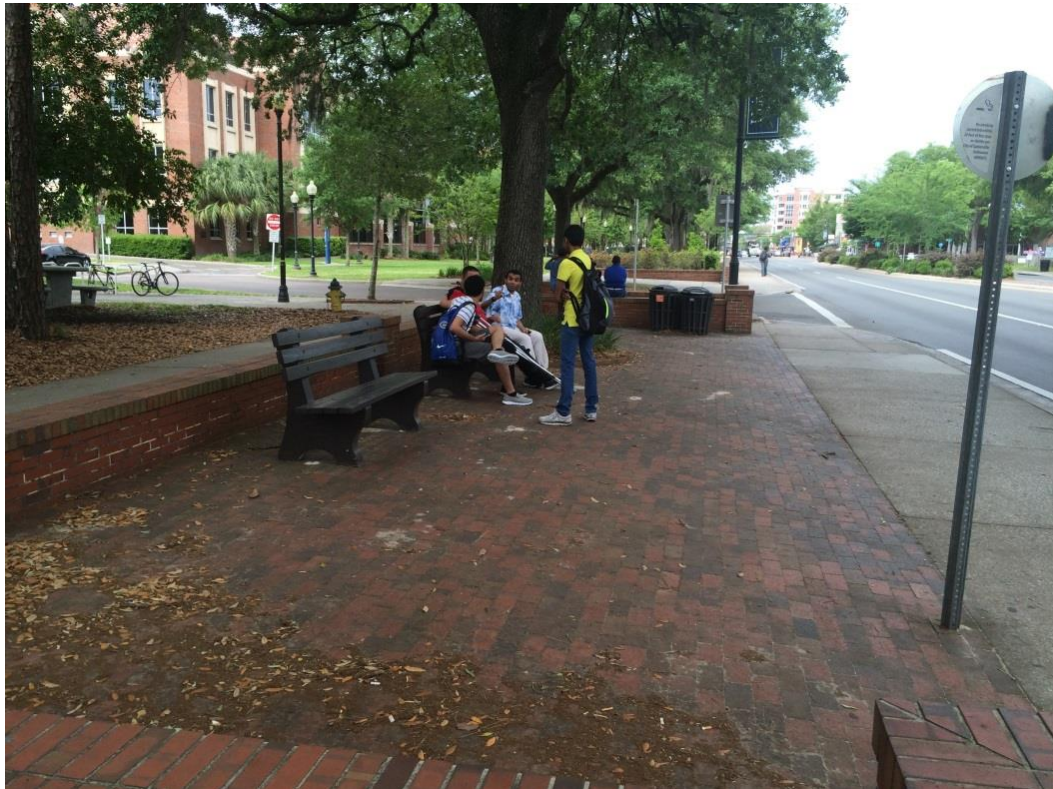
Figure 33 Photo looking west from RTS stop located on eastbound SR 26 at NW 15th Street

This RTS stop serves the University of Florida area (Figure 33). There is a similar opportunity for installation of a bus stop shelter at this location as observed at the RTS stop located on eastbound SR 26 at Buckman Dr.

This stop is located about 12 feet away from the nearest overhead light source but the presence of extensive tree canopy could block the light. Therefore, the installation of a lighted shelter is recommended.

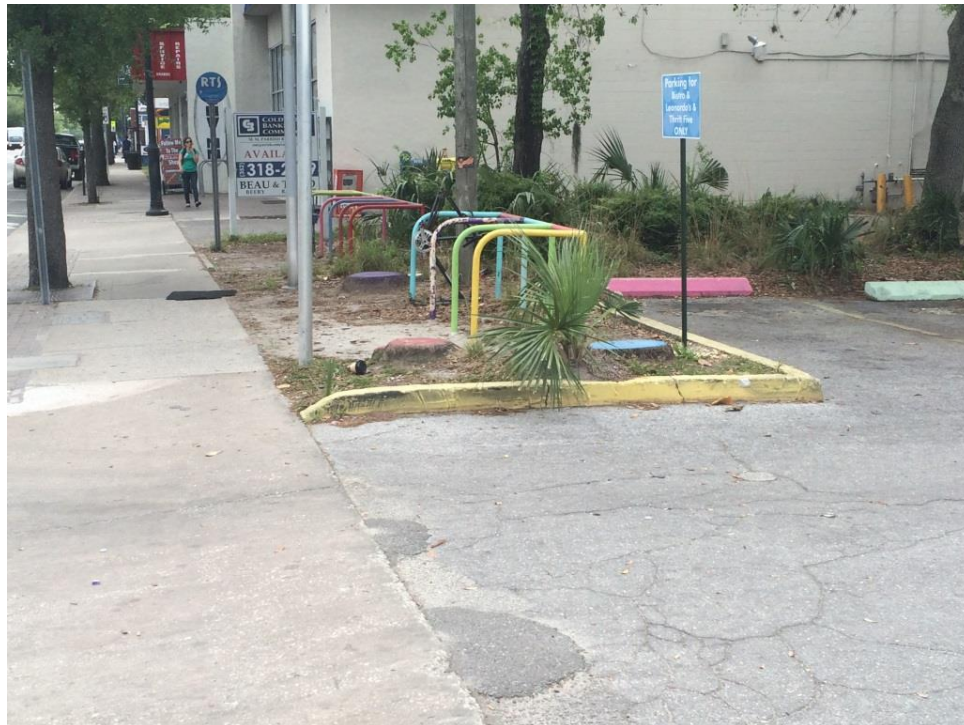
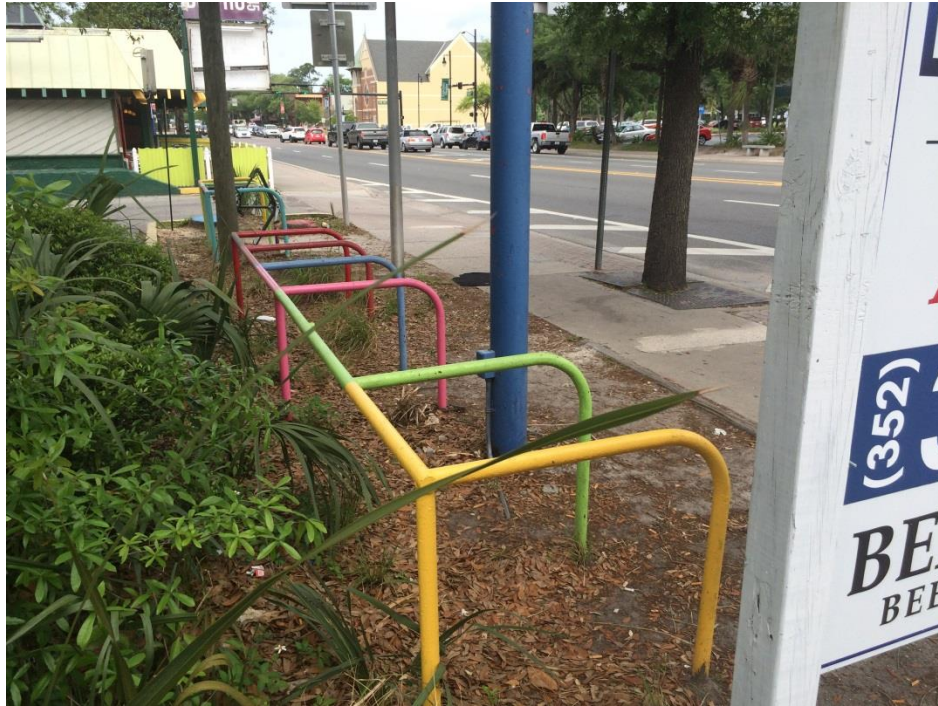
Figure 34 Photo looking east from RTS stop located on eastbound SR 26 at SW 13th Street

This stop is located about 30 feet away from the nearest overhead light source but the roof of the shelter could block the light. Therefore, the installation of a lighted shelter is recommended.

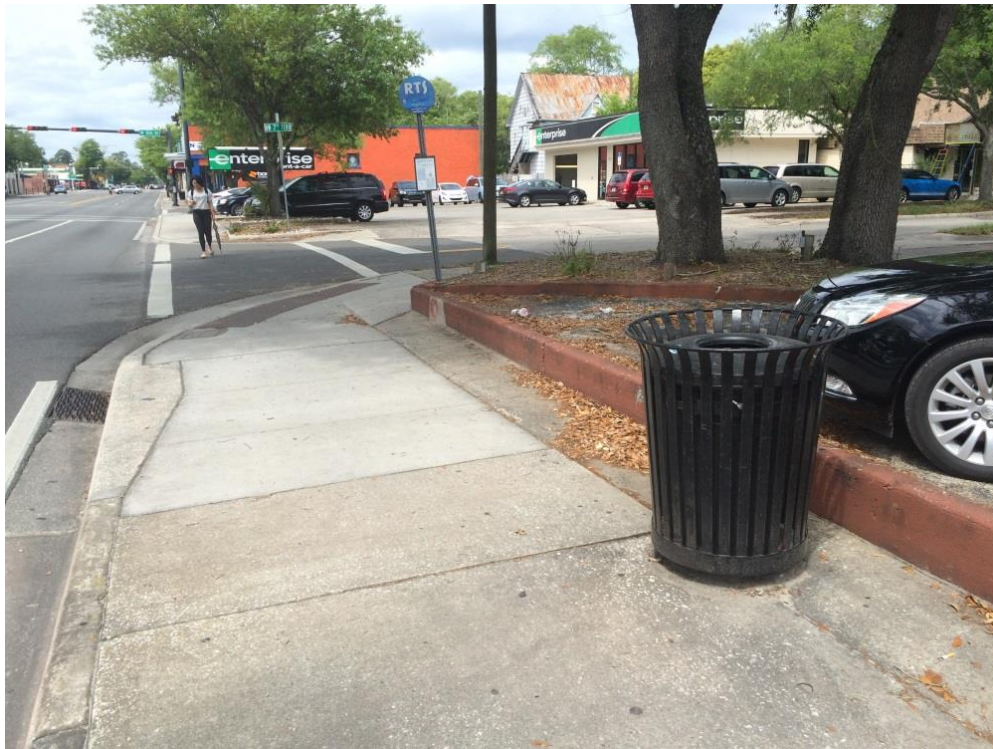
Figure 36 Photo looking west from RTS stop located on westbound SR 26 at NW 7th Terrace

This RTS stop serves a commercial area. There is adequate space within the sidewalk for a bus stop bench placement (Figure 36). Considerations to move the bus stop more towards the east away from the intersection for passenger safety is recommended. RTS indicates the bus currently stops to pick up passengers prior to the RTS bus stop sign; the sign location was chosen because it was the only location that did not require drilling the sign into concrete.

This stop is located about 60 feet away from the nearest overhead light source. Therefore, the level of lighting is not adequate and the installation of a new overhead light source no more than 30 feet from the bus stop is needed.

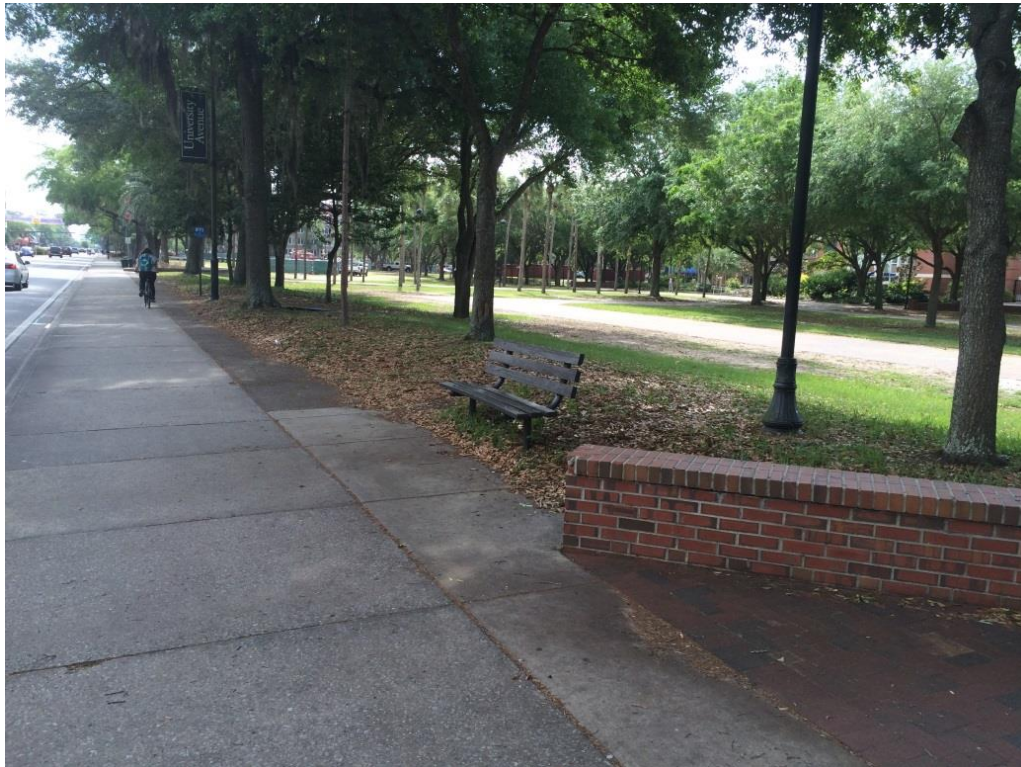
Figure 37 Photo looking east from RTS stop located on eastbound SR 26 at Gale Lemerand Drive

This stop is located about 15 feet away from the nearest overhead light source but the presence of an existing tree canopy could block the light. Therefore, the level of lighting might not be adequate.

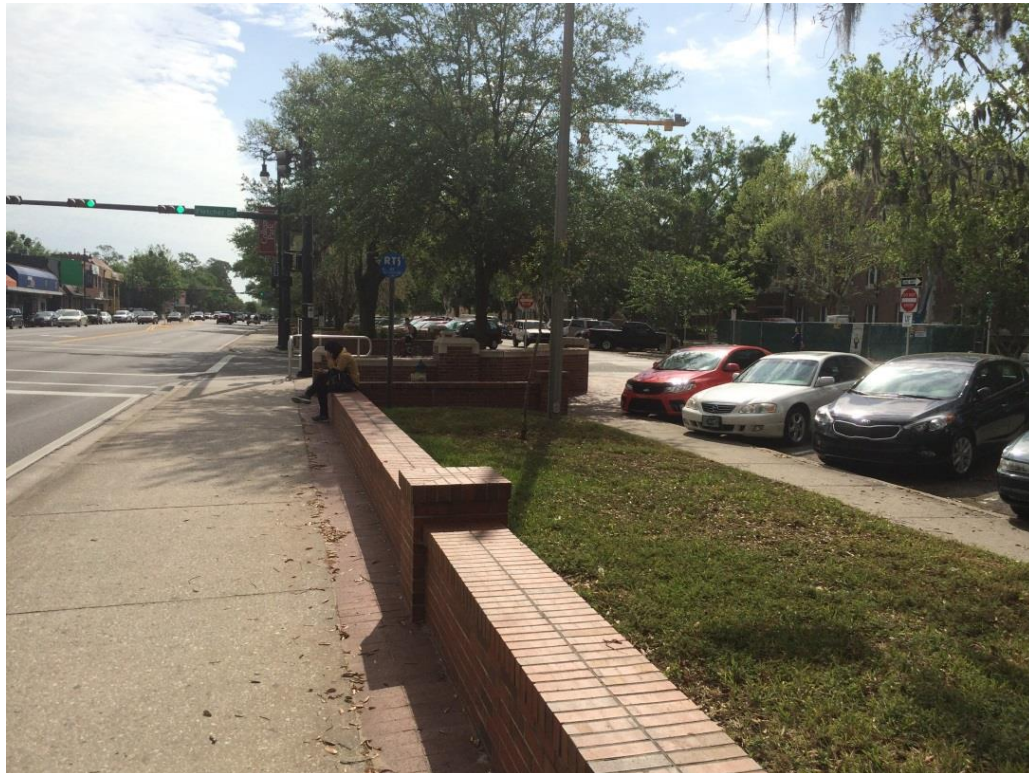
Figure 38 Photo looking east from RTS stop located on eastbound SR 26 at Fletcher Drive

There is an overhead light source located behind to the RTS stop; however, the luminaria is directed to the parking lot area. Therefore, the level of lighting might not be adequate.

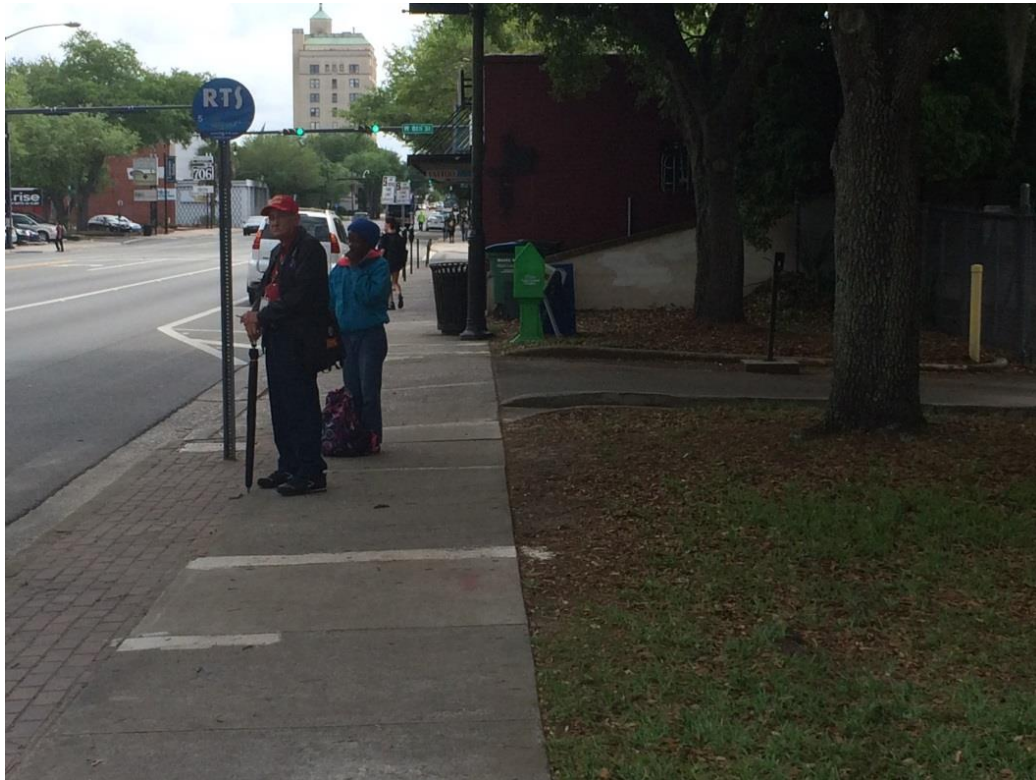
Figure 39 Photo looking east from RTS stop located on eastbound SR 26 at 9th Terrace

This stop is located about 30 feet away from the nearest overhead light source. Therefore, the level of lighting is adequate.

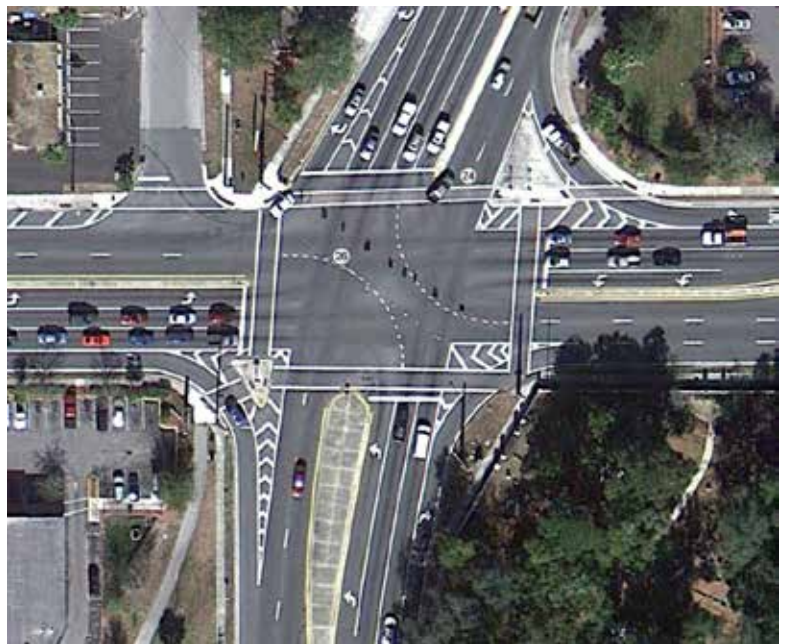
Figure 1 - SR 26 and Waldo Road, Existing Conditions

The uncontrolled right turn across the two signalized crosswalks results in pedestrians receiving a WALK signal when the cars are under free-flow operations. Essentially, this tells pedestrians they are permitted to start to cross the roadway in the direction of the signal indication. While crossings with a WALK signal can occur with conflicting turning vehicles, those vehicles approaching from a perpendicular or near perpendicular direction normally have a red signal. Thus pedestrians may reasonably expect the vehicle operators turning right from the direction that has the red traffic signal (or at least the through movements have a red traffic signal) to be required to stop and yield prior to making a right turn on red. However, under the existing condition on the southeast corner of this intersection, there is nothing to inform the free-flow north-to-east right turning motorists that the pedestrian's traffic control has changed. This could lead to confusion and safety issues at this intersection.

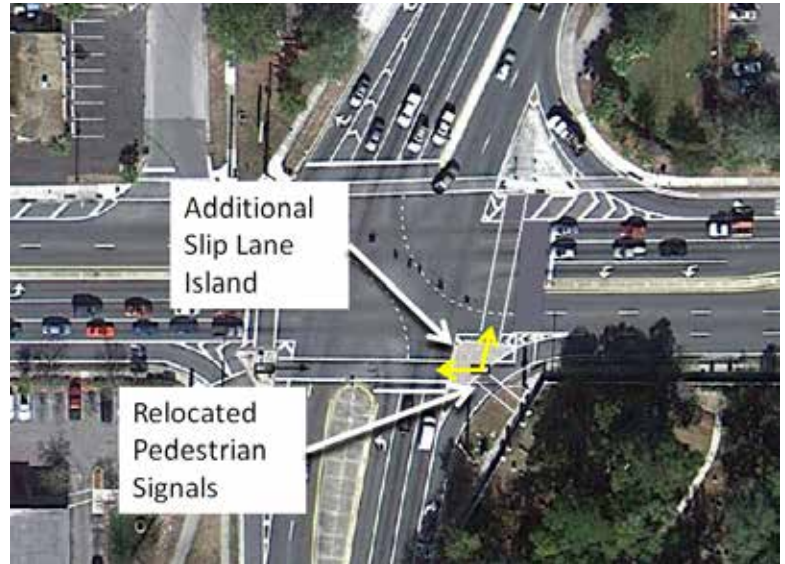
Figure 3 - SR 26 and Waldo Road, Modified Southeast Corner

The inclusion of a slip lane island on the southeast corner would also enable the reduction of pedestrian crossing distances and thus exposure times. More significant modifications using pedestrian friendly intersection design could further reduce pedestrian crossing distances. The northwest corner could be modified to reduce the crossing distance for pedestrians as well as reduce motor vehicle turning speeds. Gap acceptance slip lanes on the northeast and southwest would also reduce motor vehicle speeds across the pedestrian crosswalks. Additionally, modified slip lanes would put the pedestrians crossing in a better position to be seen by approaching motorists. Depending on the size of the channelization islands installed, they could be used to provide a gateway treatment onto the University Avenue corridor (Figure 3). (113)

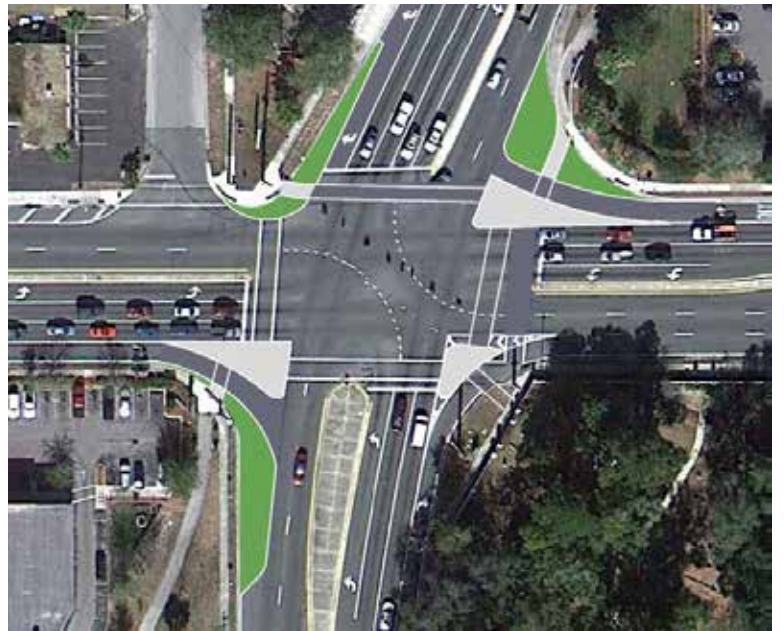
Figure 2 - SR 26 and Waldo Road, Compact Design

The signalized pedestrian movement in conflict with the free-flow right turn is also inconsistent with normal signal operations and the MUTCD¹¹. Discussions with FDOT commenters suggest that restricting this free-flow right turn is not desirable. This leaves the alternative of removing the signalized crossing of the uncontrolled vehicular movement. Adding a concrete slip lane island on the southeast corner of the intersection would allow for the pedestrian signal hardware to be moved to the slip lane island and thus provide for signalized pedestrian crossings across only the signalized motor vehicle movements. The construction of this island would also reduce the needed pedestrian clearance intervals for this intersection and in turn reduce loss time to signalized vehicular movements (Figure 2). (111 and 112)

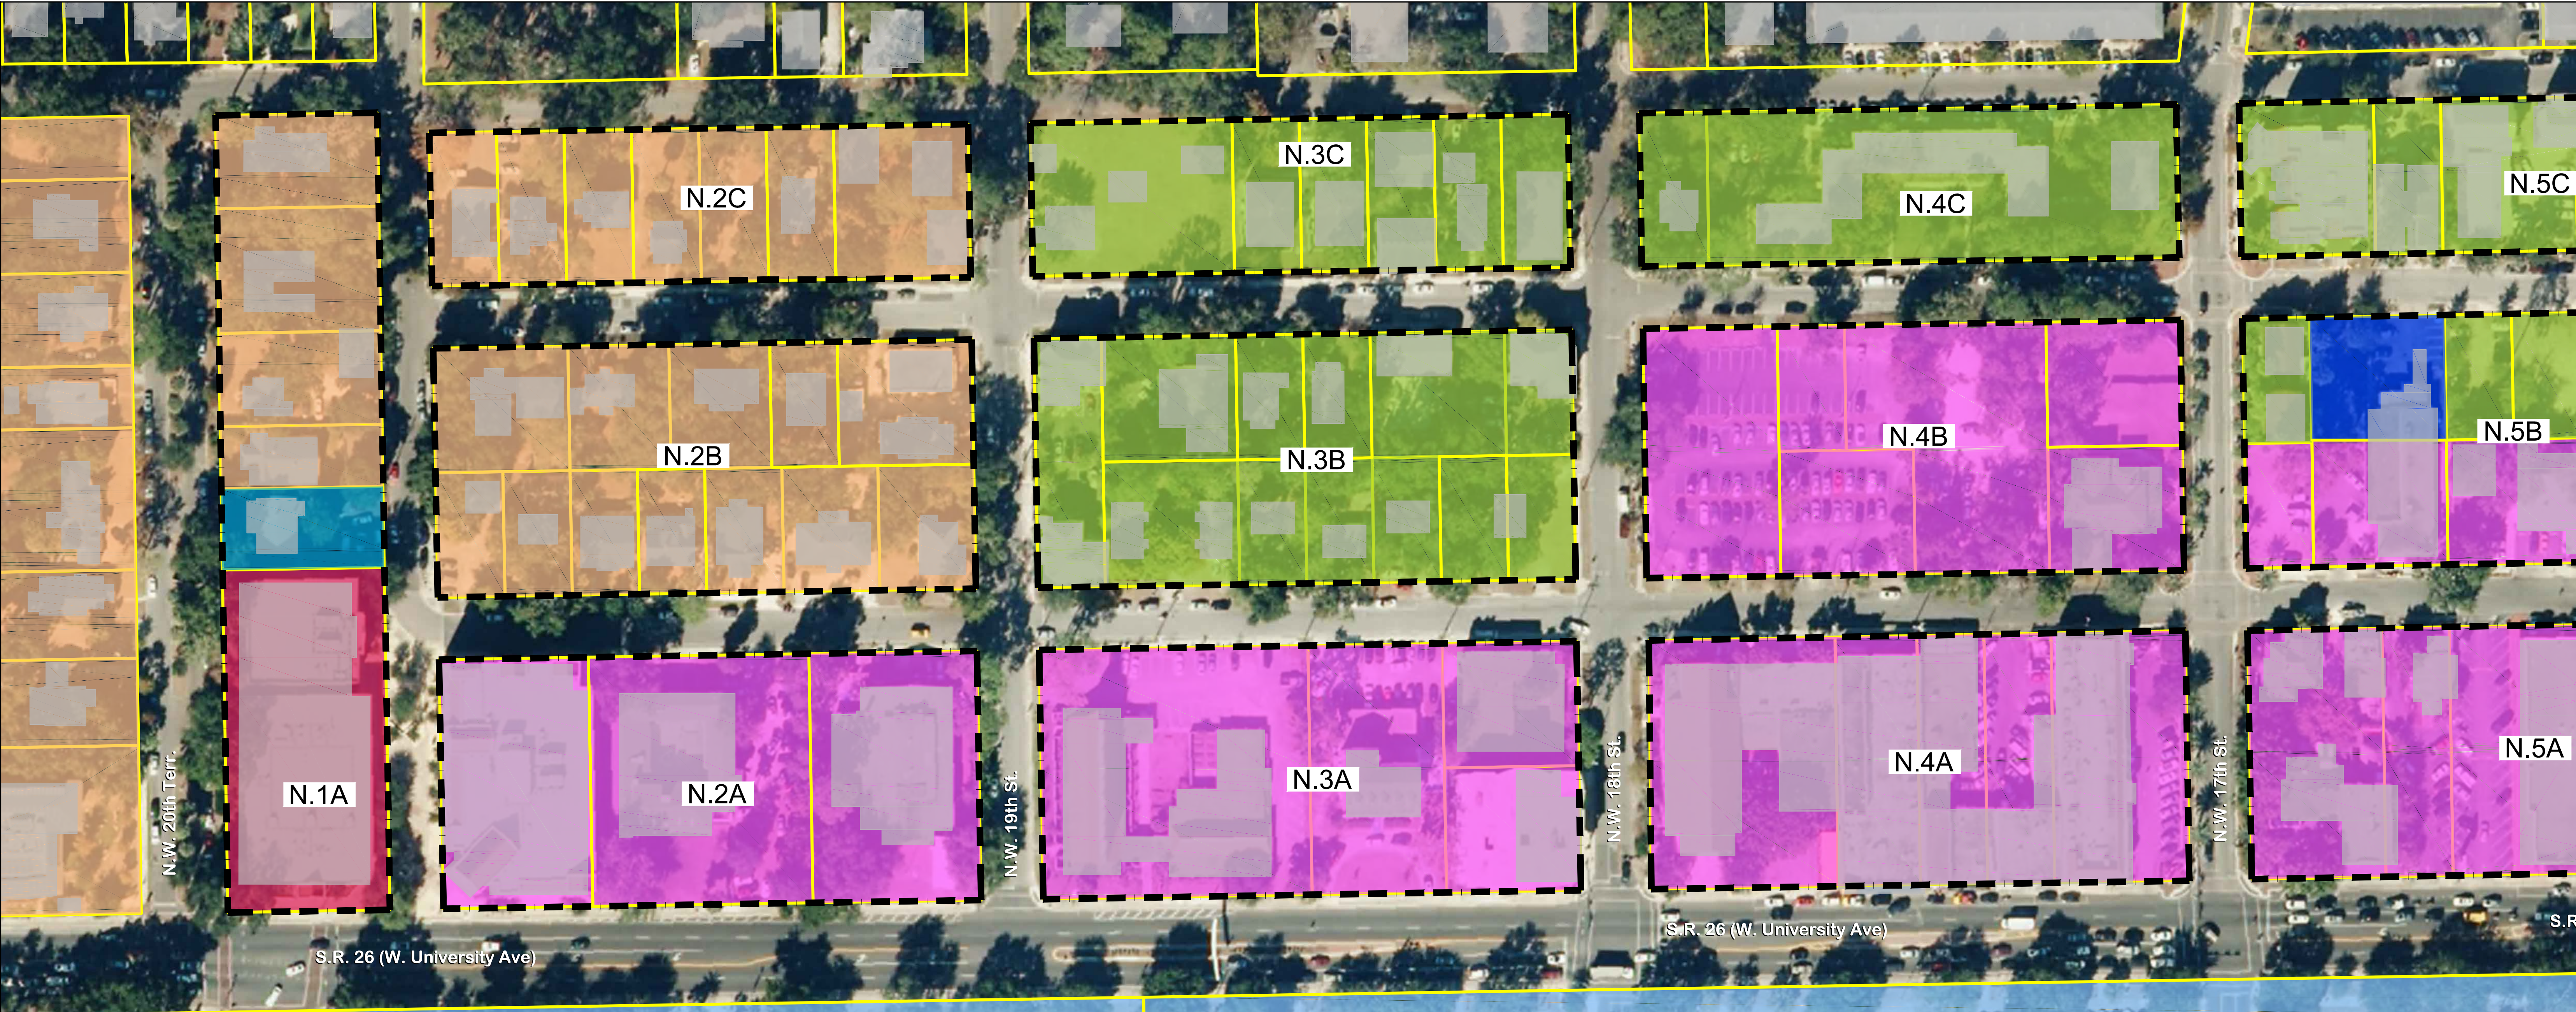
BLOCK N.1A			
LAND USE:	TOTAL AREA:	CURRENT (sf)	FUTURE (sf/du)
O	35,773	24,319	41
PUD	8,482	1,727	
RL	39,005	8,933

BLOCK N.2C:			
LAND USE:	TOTAL AREA:	CURRENT (sf)	FUTURE (sf/du)
RL	53,227	10,573	
BLOCK N.2B:			
LAND USE:	TOTAL AREA:	CURRENT (sf)	FUTURE (sf/du)
RL	86,479	21,842	
BLOCK N.2A:			
LAND USE:	TOTAL AREA:	CURRENT (sf)	FUTURE (sf/du)
UMU1	86,400	42,052	147

BLOCK N.4C:			
LAND USE:	TOTAL AREA:	CURRENT (sf)	FUTURE (sf)
MUR	53,227	10,573	53
BLOCK N.4B:			
LAND USE:	TOTAL AREA:	CURRENT (sf)	FUTURE (sf)
UMU1	86,481	5,263	87
BLOCK N.4A:			
LAND USE:	TOTAL AREA:	CURRENT (sf)	FUTURE (sf)
UMU1	86,310	55,341	146
