SR 26 / University Avenue Multimodal Emphasis Corridor Study

Phase 2 Report

June 1, 2015

**Metropolitan Transportation Planning Organization
for the Gainesville Urbanized Area**

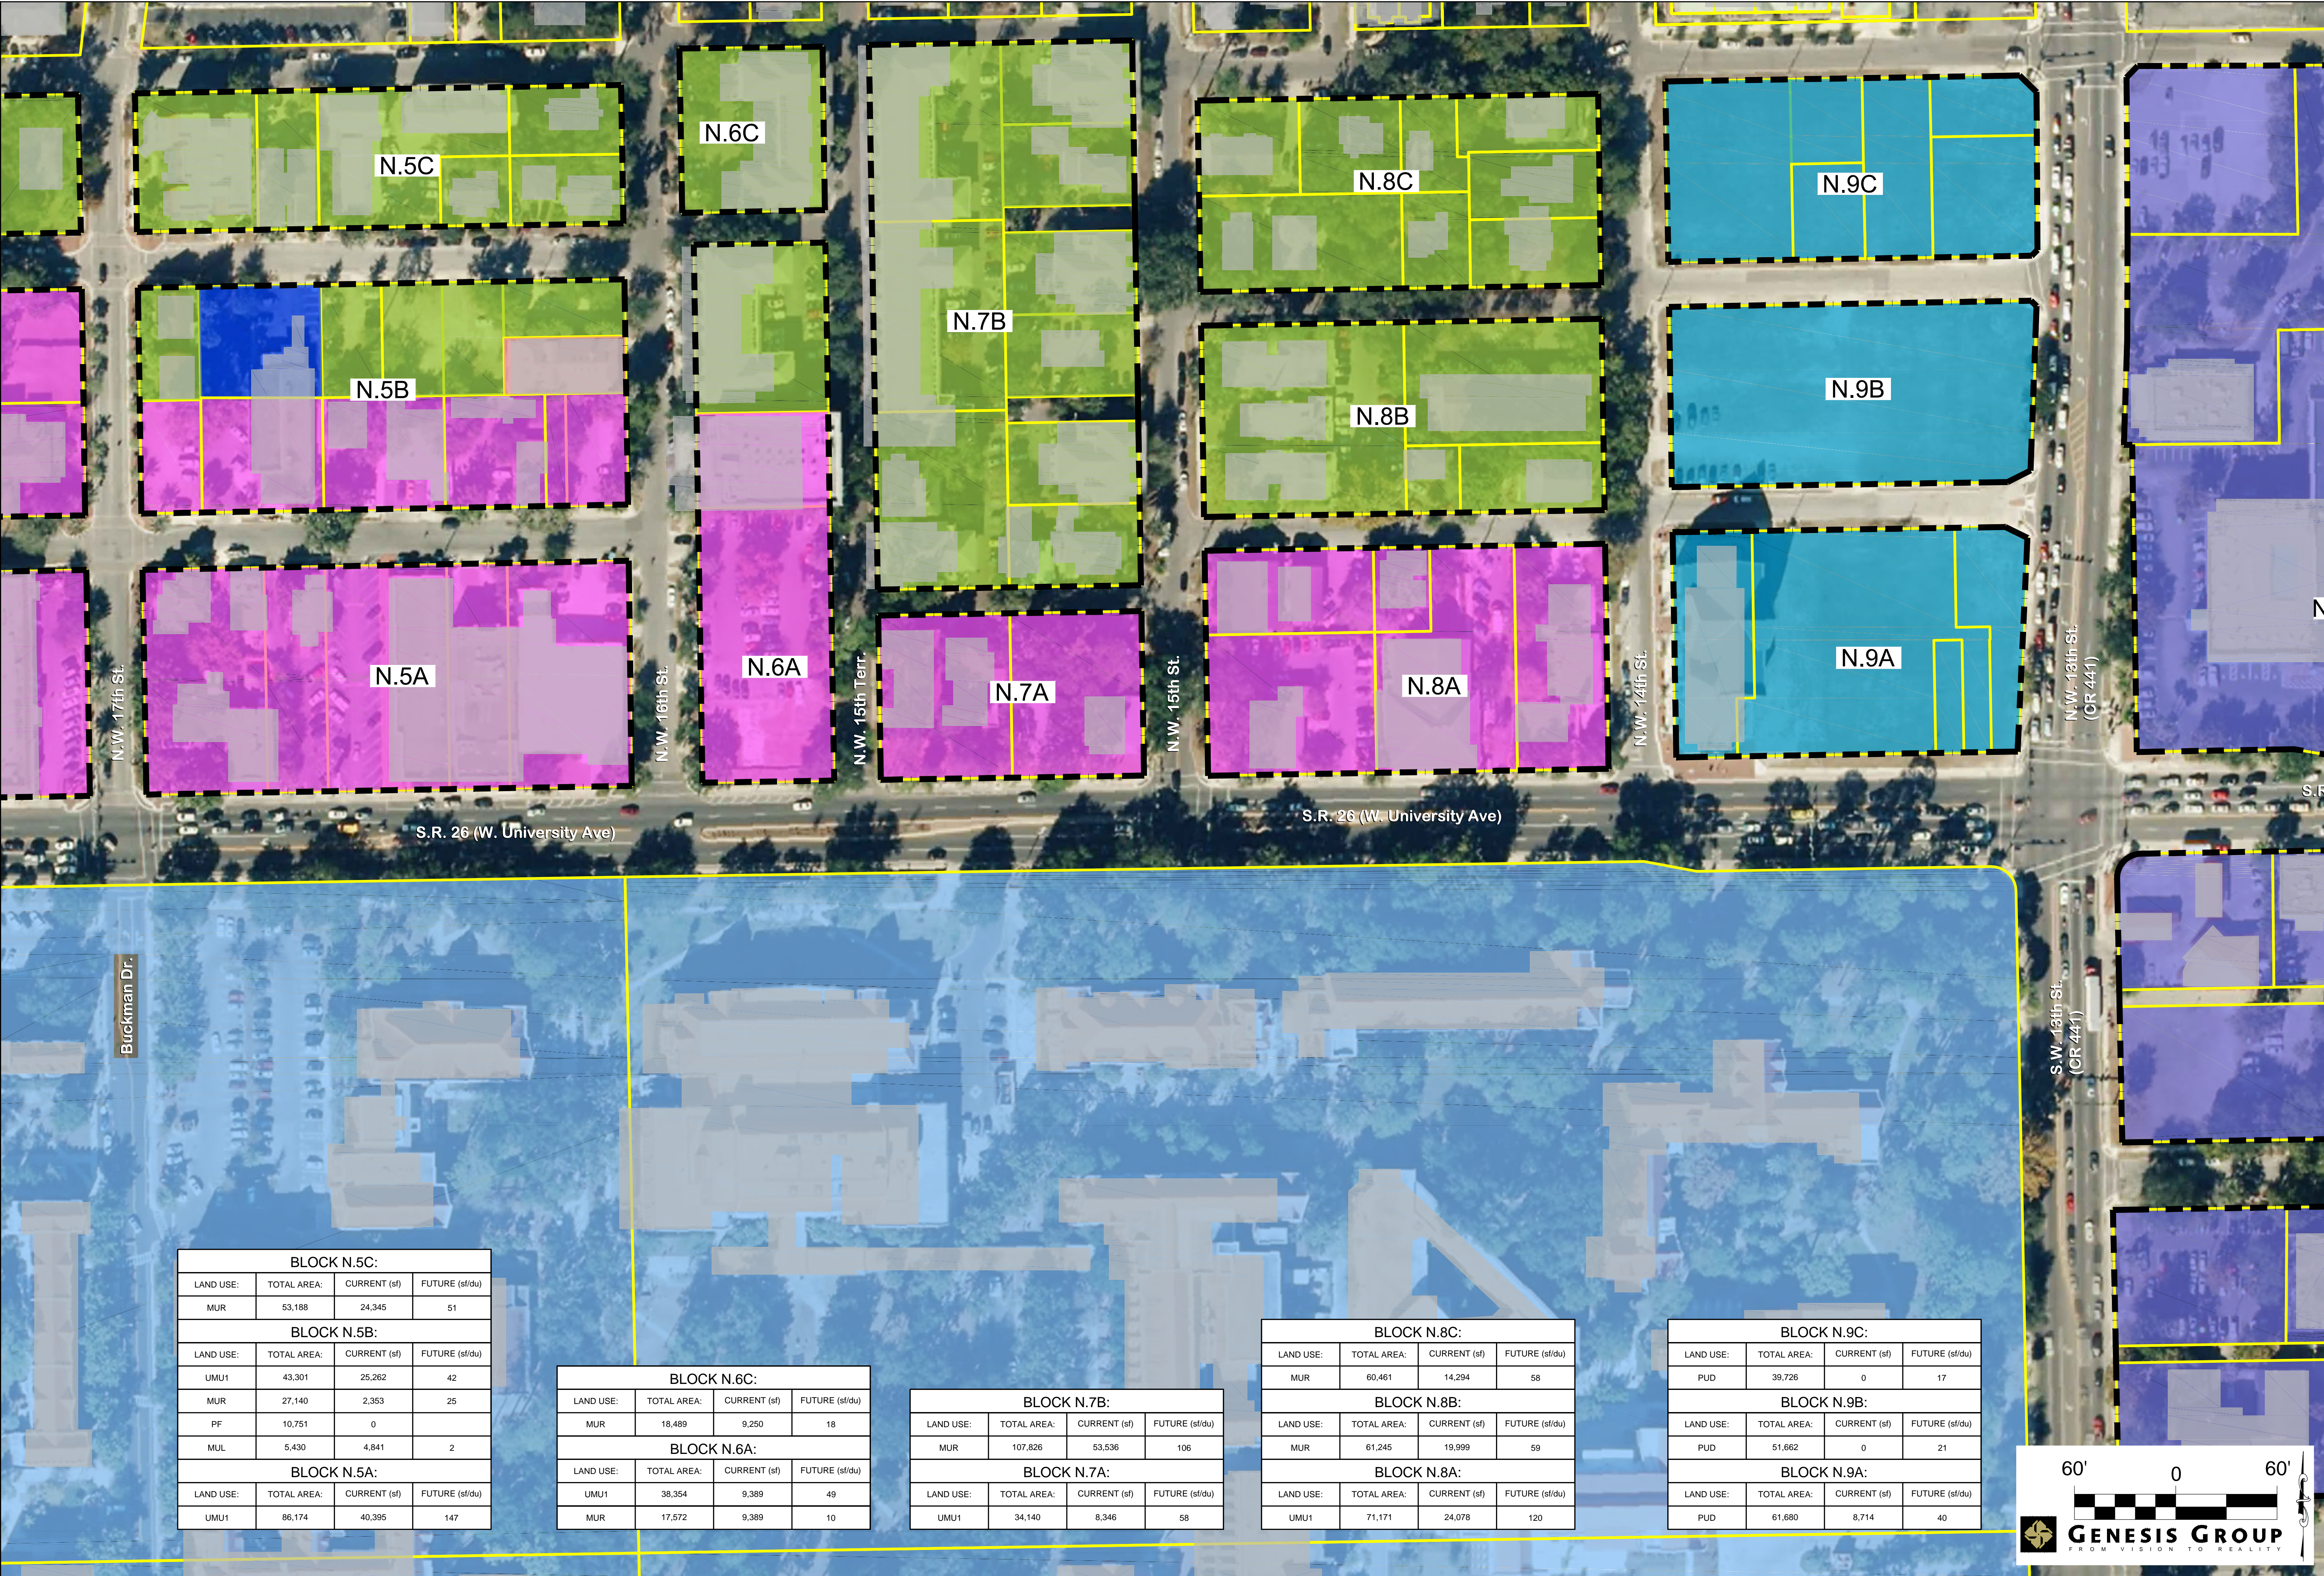
BLOCK N.5C:			
LAND USE:	TOTAL AREA:	CURRENT (sf)	FUTURE (sf/du)
MUR	53,188	24,345	51
BLOCK N.5B:			
LAND USE:	TOTAL AREA:	CURRENT (sf)	FUTURE (sf/du)
UMU1	43,301	25,262	42
MUR	27,140	2,353	25
PF	10,751	0	
MUL	5,430	4,841	2
BLOCK N.5A:			
LAND USE:	TOTAL AREA:	CURRENT (sf)	FUTURE (sf/du)
UMU1	86,174	40,395	147

BLOCK N.6C:			
LAND USE:	TOTAL AREA:	CURRENT (sf)	FUTURE (sf/du)
MUR	18,489	9,250	18
BLOCK N.6A:			
LAND USE:	TOTAL AREA:	CURRENT (sf)	FUTURE (sf/du)
UMU1	38,354	9,389	49
MUR	17,572	9,389	10

BLOCK N.8C:			
LAND USE:	TOTAL AREA:	CURRENT (sf)	FUTURE (sf/du)
MUR	60,461	14,294	58
BLOCK N.8B:			
LAND USE:	TOTAL AREA:	CURRENT (sf)	FUTURE (sf/du)
MUR	61,245	19,999	59
BLOCK N.8A:			
LAND USE:	TOTAL AREA:	CURRENT (sf)	FUTURE (sf/du)
UMU1	71,171	24,078	120

BLOCK N.9C:			
LAND USE:	TOTAL AREA:	CURRENT (sf)	FUTURE (sf/du)
PUD	39,726	0	17
BLOCK N.9B:			
LAND USE:	TOTAL AREA:	CURRENT (sf)	FUTURE (sf/du)
PUD	51,662	0	21
BLOCK N.9A:			
LAND USE:	TOTAL AREA:	CURRENT (sf)	FUTURE (sf/du)
PUD	61,680	8,714	40

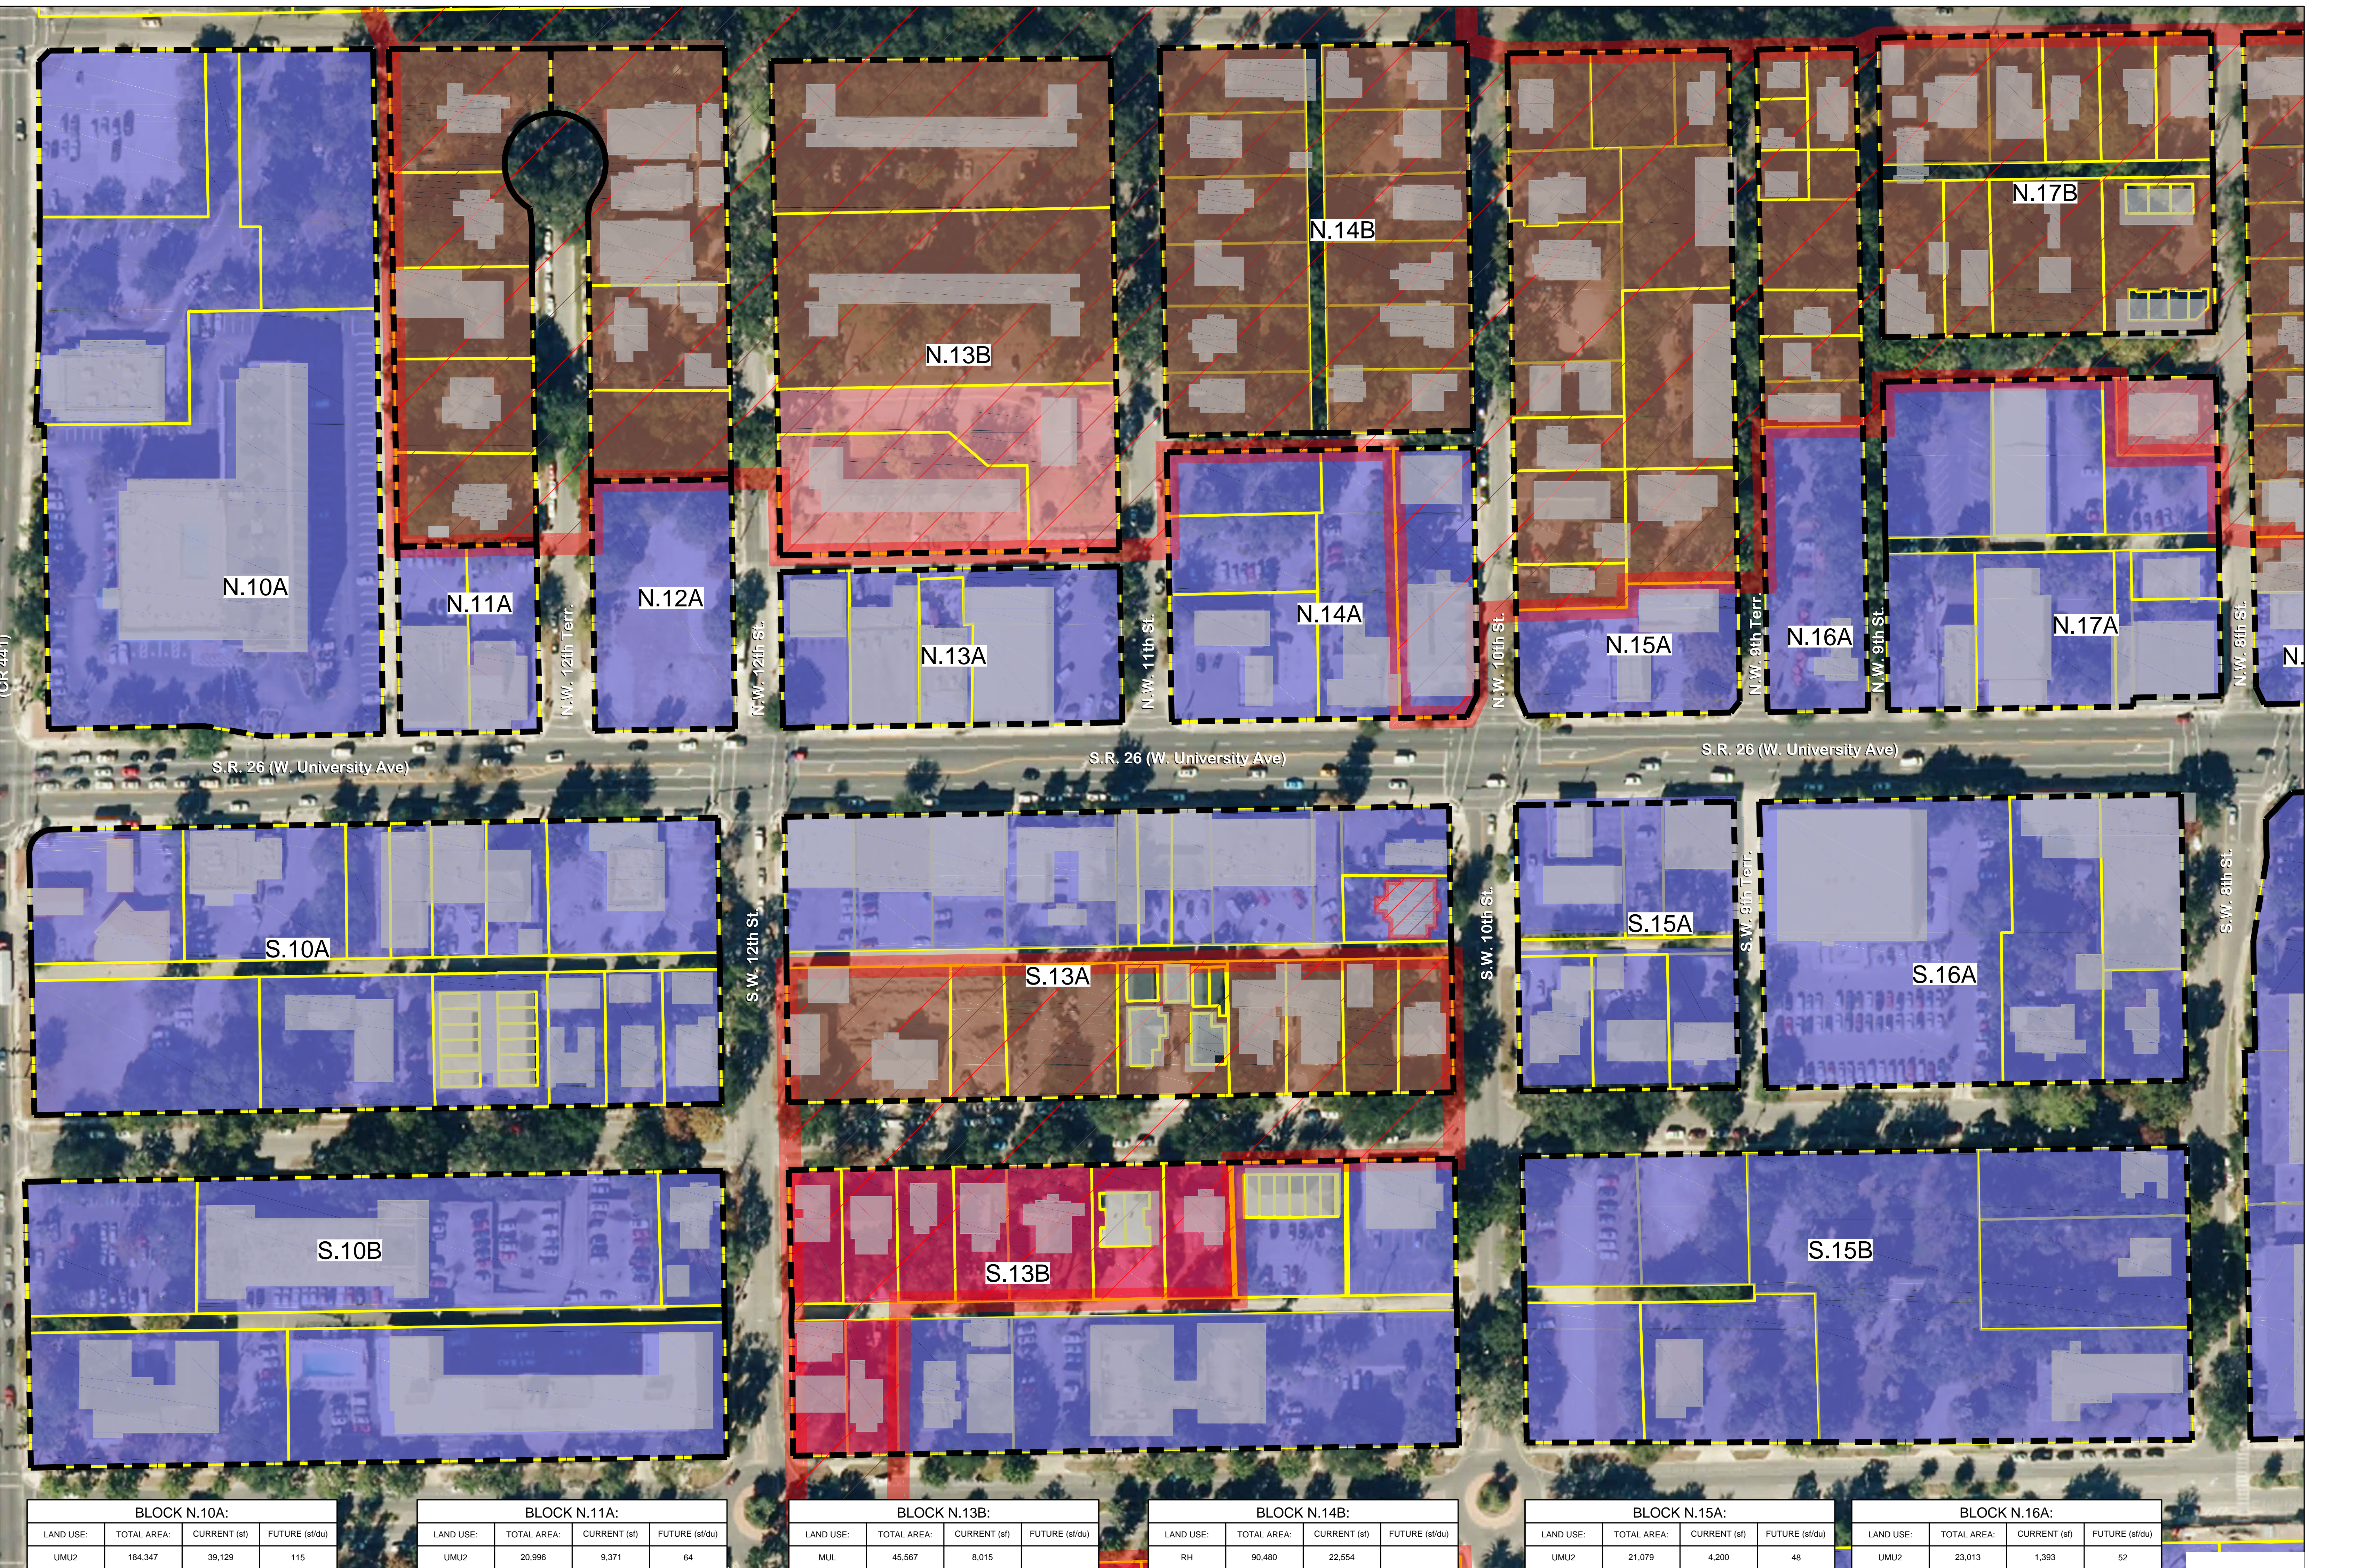
BLOCK N.10A:			
LAND USE:	TOTAL AREA:	CURRENT (sf)	FUTURE (sf/du)
UMU2	184,347	39,129	115

BLOCK S.10A:			
LAND USE:	TOTAL AREA:	CURRENT (sf)	FUTURE (sf/du)
UMU2	143,323	46,319	339
