# **SR 26 / University Avenue Multimodal Emphasis Corridor Study**

## **DRAFT Phase 1 Report**

**November 2014**

**Metropolitan Transportation Planning Organization  
for the Gainesville Urbanized Area**

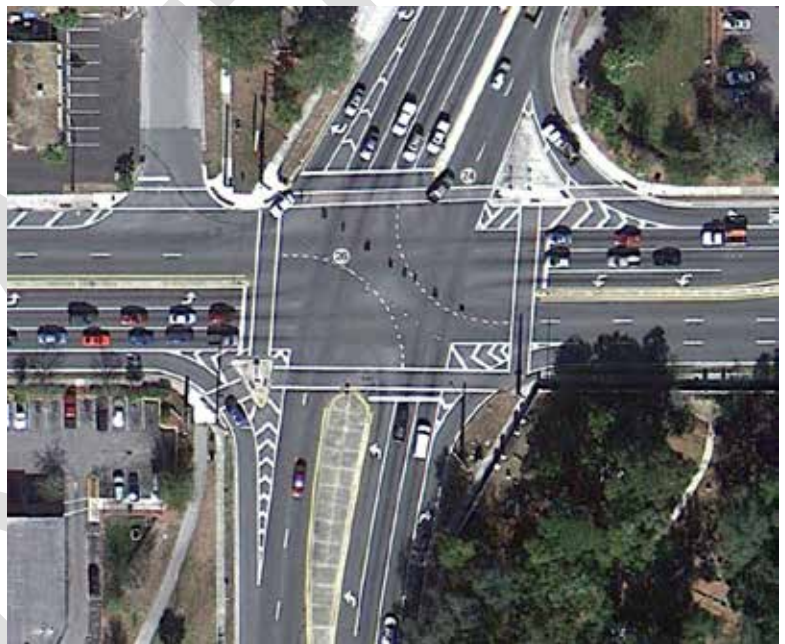
Figure 1 - SR 26 and Waldo Road, Existing Conditions

The uncontrolled right turn across the two signalized crosswalks results in pedestrians receiving a WALK signal when the cars are under free-flow operations. Essentially, this tells pedestrians they are permitted to start to cross the roadway in the direction of the signal indication. While crossings with a WALK signal can occur with conflicting turning vehicles, those vehicles approaching from a perpendicular or near perpendicular direction normally have a red signal. Thus pedestrians may reasonably expect the vehicle operators turning right from the direction that has the red traffic signal (or at least the through movements have a red traffic signal) to be required to stop and yield prior to making a right turn on red. However, under the existing condition on the southeast corner of this intersection, there is nothing to inform the free-flow north-to-east right turning motorists that the pedestrian's traffic control has changed. This could lead to confusion and safety issues at this intersection.
